BUILDING SURVEY REPORT

The format of this Mi BUILDING SURVEY REPORT is consistent with the guidance note requirements for a Survey Level 3 as defined by RICS Surveys of Residential Property 3rd edition May 2016

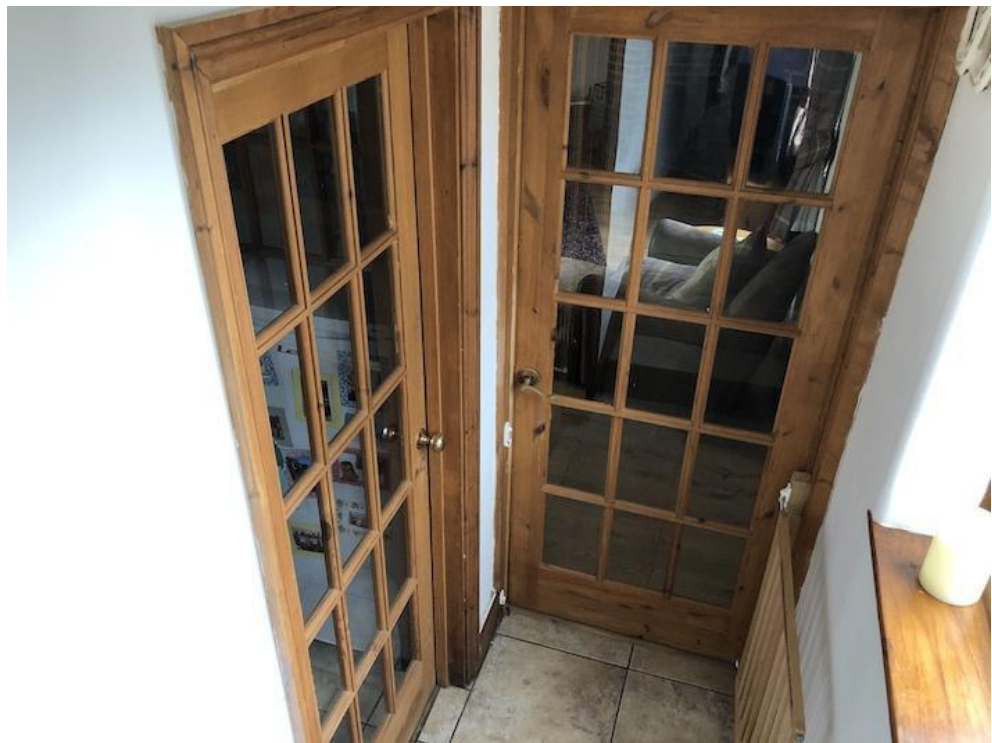
Glazing in the door between the hallway and the kitchen & the hallway and the reception room is not marked as being of safety glass. In addition the glass to the front porch (exterior) is also not marked as safety glass. This may present a significant risk to safety, especially for the young and elderly. See section 5.7.

No safety glass

Action Required	You should consider replacing the glass or doors for the hallway to kitchen and hallway to reception room as these are not marked as having safety glass fitted. This poses a health and safety risk to users in case a pane breaks during use. A lock should be fitted to the bathroom door. The bathroom missing skirting should be replaced. The reception door to the hallway should have its frame repaired. Door hinges and locks should be regularly lubricated. Internal timbers should be inspected regularly for evidence of bowing or distortion, woodworm and other defects.

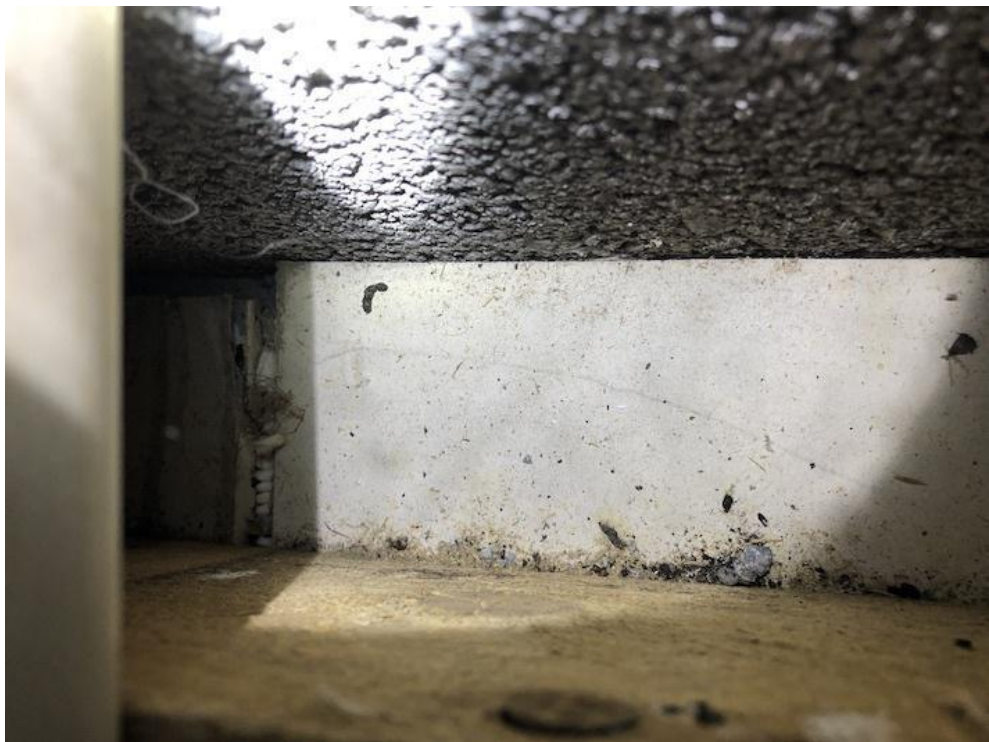
<p>Insect and Rodent Infestations</p>	<p>Droppings were noted in the roof space suggest that the property has been affected by infestations of mice/rodents, as is commonly the case in properties in rural locations. Rodents can be responsible for the spread of diseases such as salmonella and Weils disease, and so care should be taken when entering such spaces. Mice and other rodents can gnaw through insulation and wiring, and damage furniture and other possessions that may be stored.</p>

Rodent droppings

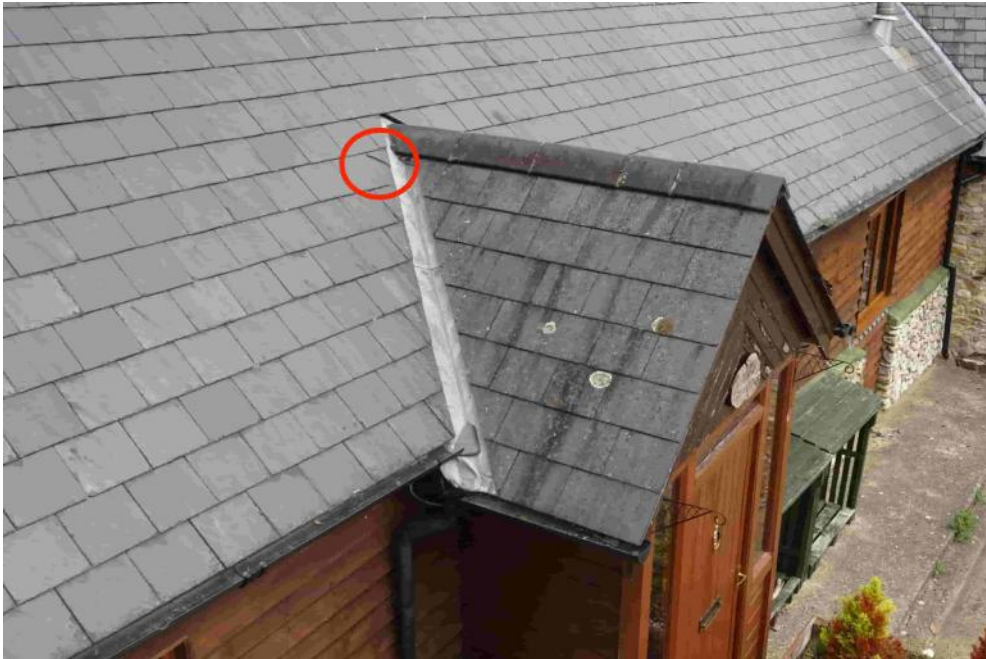
Broken slate to left of porch roof

<p>Action Required</p>	<p>Pitched Sections:</p> <p>The sag to the ridge looks to be located mostly if not fully on the right side adjoining neighbours property, however the sagging section closely runs next to or over the party line, this is seemingly caused by roof spread on the adjoining property roof structure but may still be ongoing and will require monitoring going forwards to ensure it is not active movement.</p> <p>The roofing underfelt at the eaves to guttering should be replaced to prevent future moisture ingress, this generally requires a partial strip off of slates in order to fit new felt before the roof covering is refitted. You should note that scaffolding may be required in order to undertake this type of work.</p> <p>Any slipped, missing or broken tiles on the roof pitches should be repaired and replaced. You should carry out a thorough visual inspection at least once a year, ideally in the Spring to identify and repair any damage that could have been caused by winter weather. Any missing mortar at the verges and beneath any hip or ridge tiles should be replaced. Any moss or other accumulated plant matter should be cleared</p> <p>The boot room roof should be extended, or replaced fully, to meet the rear elevation wall and to prevent water ingress to the room.</p> <p>Ongoing, carry out normal maintenance including the removal of moss build-up.</p>

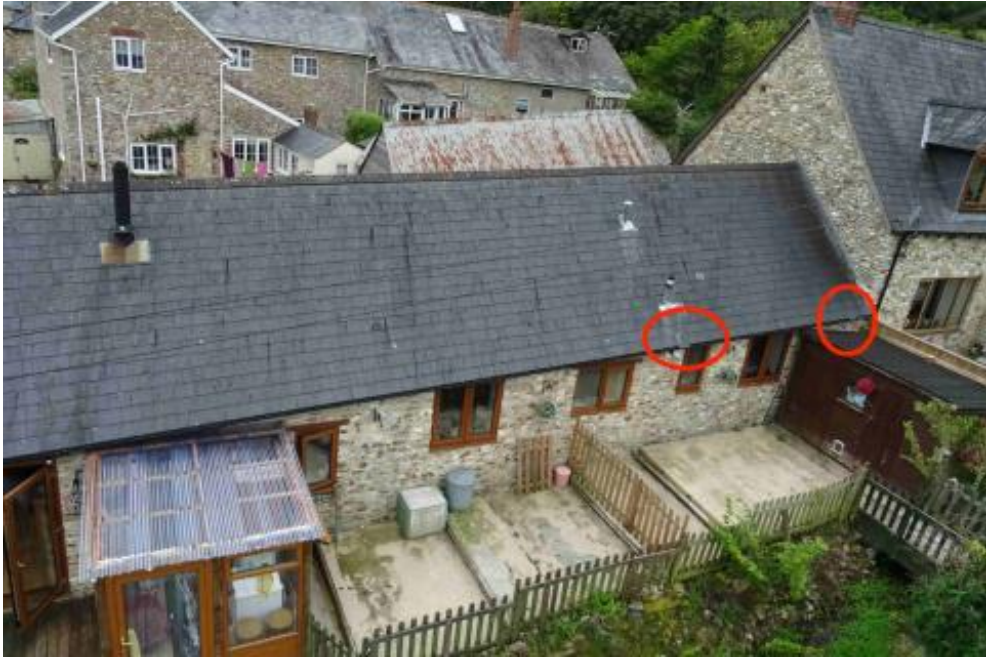
Slipped slates at rear

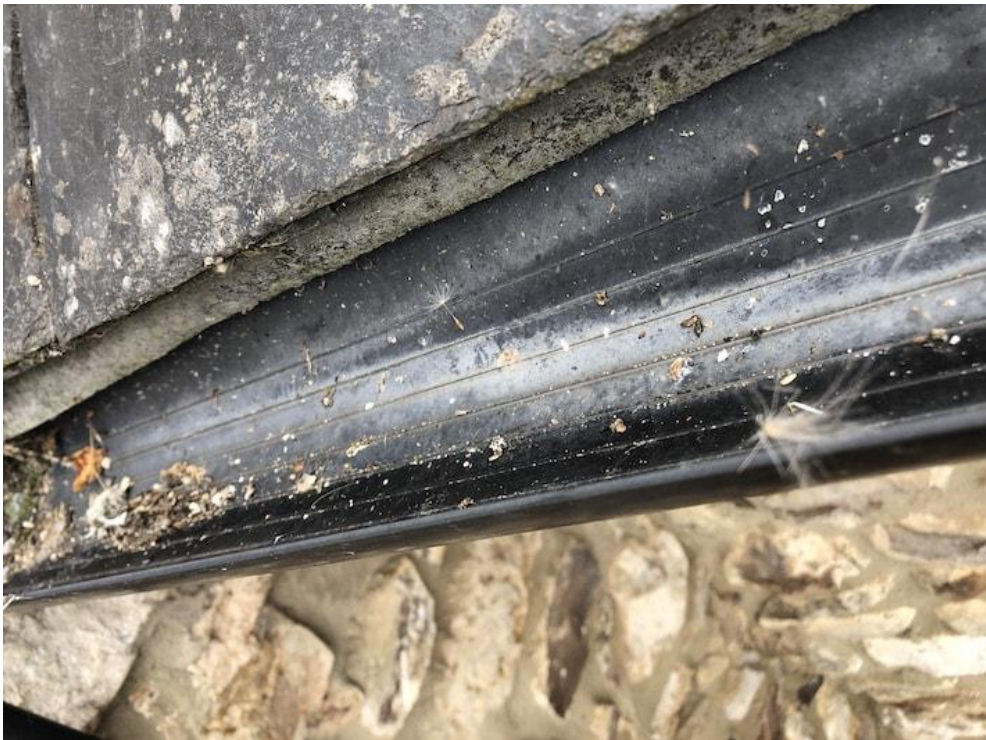
Lack of felt in gutter, this is one of the larger remaining felt areas

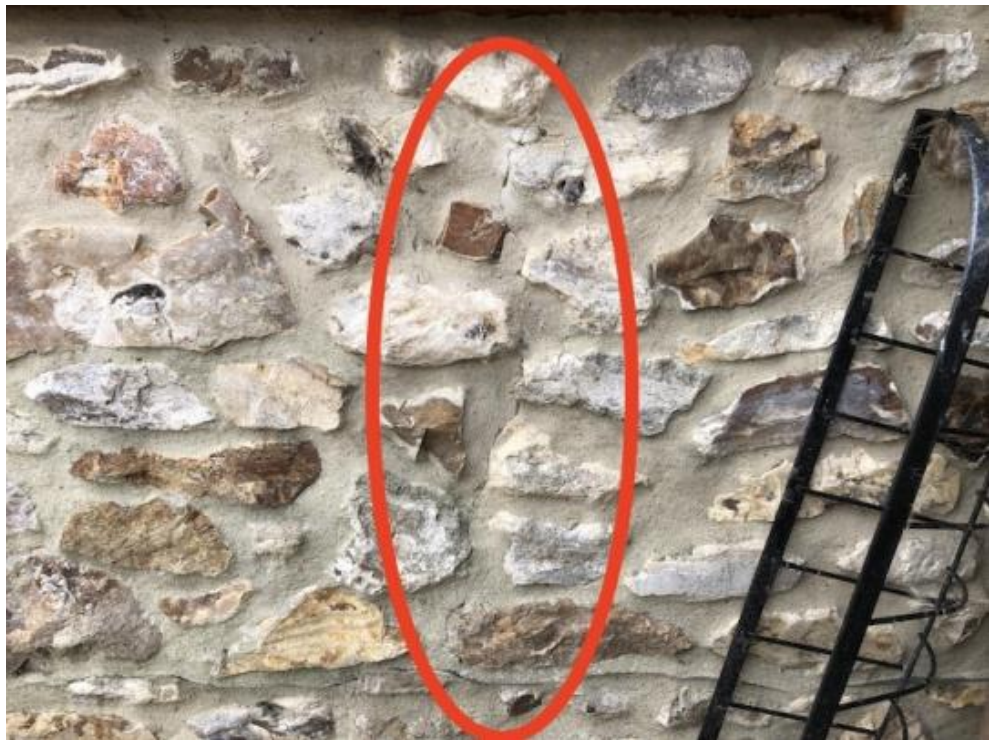
Wall crack rear wall below Bedroom 2 window

Action Required	<p>The mortar cracks to the elevation walls should be repaired and made good to prevent damp ingress. These should be monitored post repair to ensure there is no ongoing movement however as this survey is only a snap shot in time and not a recurring monitoring inspection.</p> <p>The eroded pointing/mortar to both front and rear elevations should be repaired to prevent dampness entering the building.</p> <p>The lack of a DPC to the front elevation is currently not causing an issue. Changes to the ground level in future (for example a new road surface) could result on higher levels of dampness in the base of the walls. When/if this happens then walls without a DPC can be more vulnerable to dampness problems than walls that have a DPC.</p> <p>Walls should be examined regularly to inspect for changes in the nature of any cracking or other defects that may become apparent (including issues surrounding the cement mortar used in the exterior wall construction over lime).</p> <p>You should carry out a thorough visual inspection at least once a year, ideally in the Spring to identify and repair any damage that could have been caused by winter weather.</p>

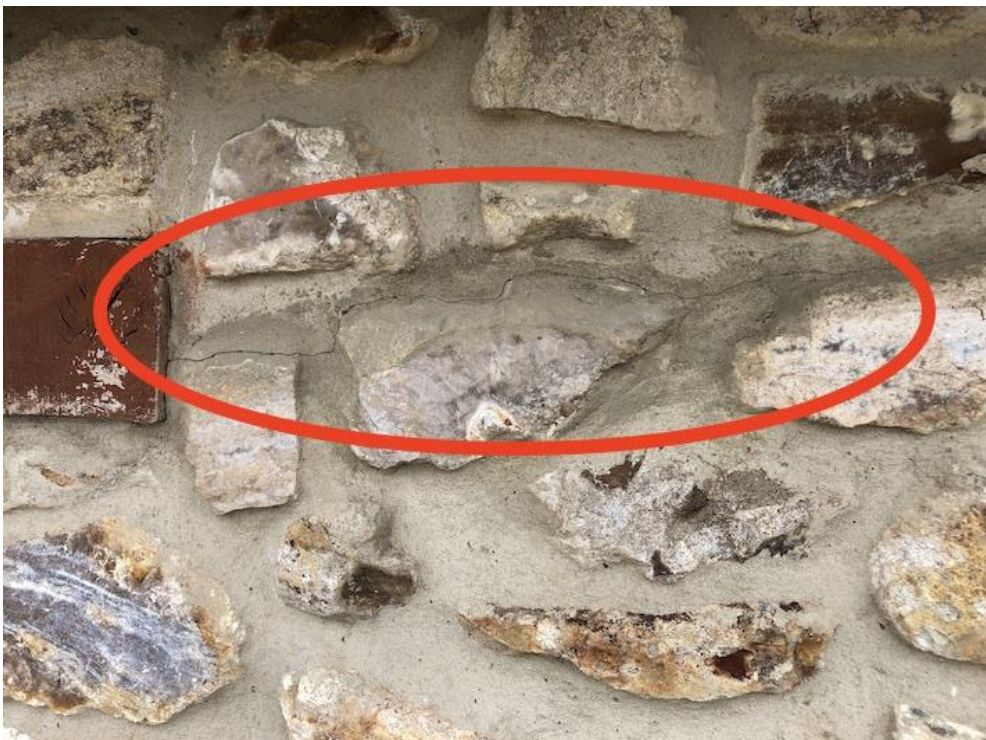
Wall crack rear wall to left bathroom window

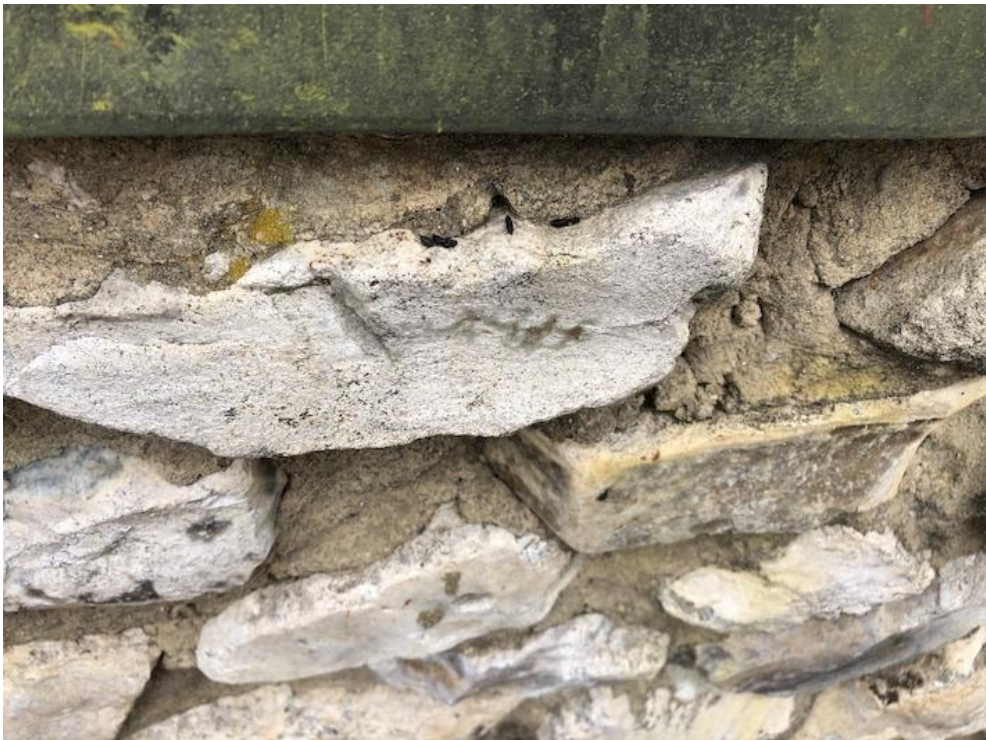
Mortar decay front elevation under right window

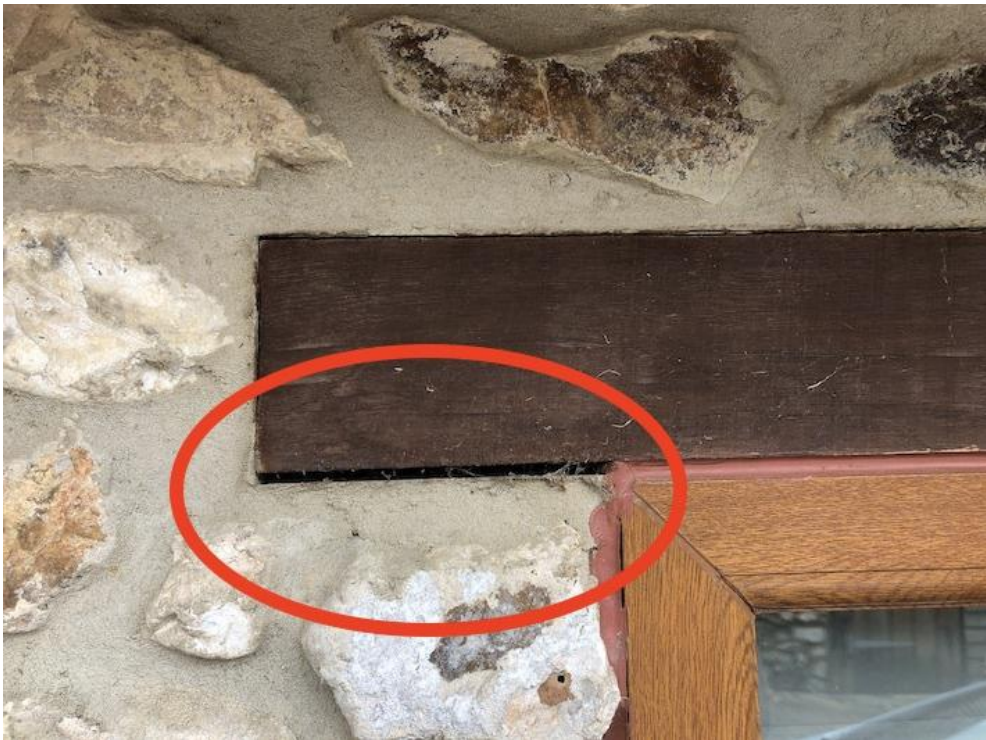
Front left lintel shrunk

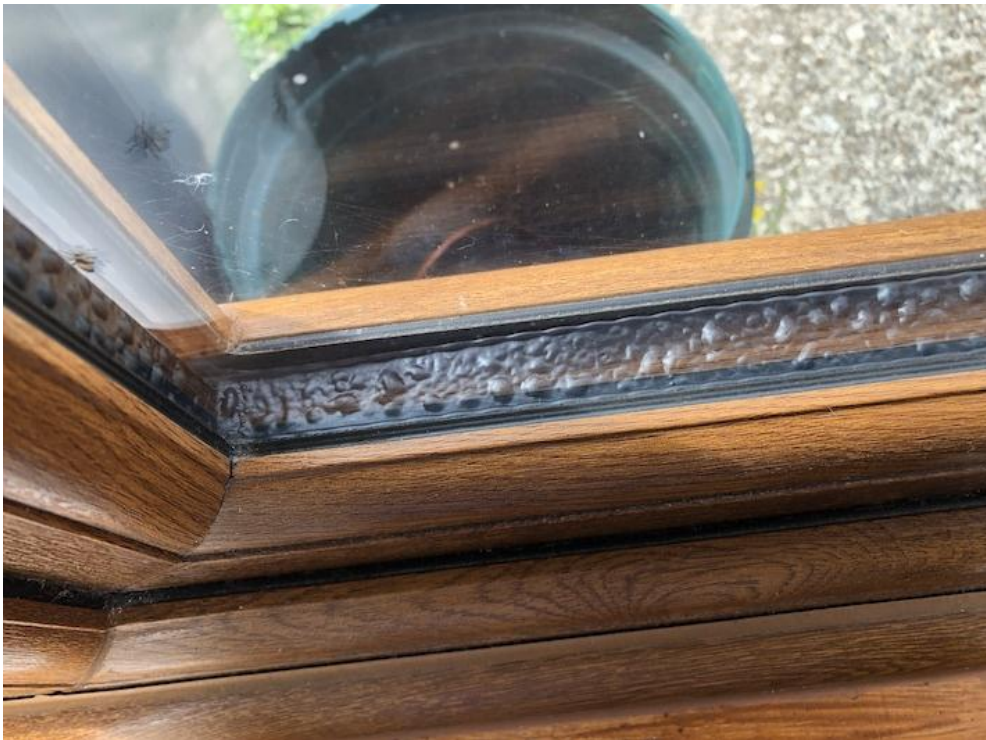
Window bubbled

Action Required	<p>Due to the volume/cost of items that require replacement, or significant repair, a condition rating of 3 has been applied.</p> <p>The timber front door should be replaced due to its current condition and height above the threshold.</p> <p>You should consider replacing the single glazed glass of the front porch as non of it is marked as having safety glass fitted. This poses a health and safety risk to users in case a pane breaks during use.</p> <p>The uPVC rear door of the boot room requires repair or replacement of the door and frame due to its current condition. The glass unit is also blown and requires replacement too.</p> <p>Failed sealed glazing units, as noted above in the condition section, require replacement. It should also be considered that, where some sealed units within a window have failed, others may also fail in due course.</p> <p>The front elevation windows bubbling is significant and may require new frames and not just new sealed glazing units to be fitted.</p> <p>The front left window cill should be repaired or replaced.</p> <p>The ensuite window handle should be repaired.</p> <p>Normal maintenance of frames, hinges and locks is required.</p> <p>Be aware that previous owners may have distributed multiple sets of keys for the windows and doors to individuals not known to you. When purchasing a property, you should consider the cost of replacing all of the door and window locks as soon as possible after you take up occupation. When doing this you should consult your insurers to ensure that you meet their requirements for security, and obtain any discounts that may be available by improving the security of the property.</p>

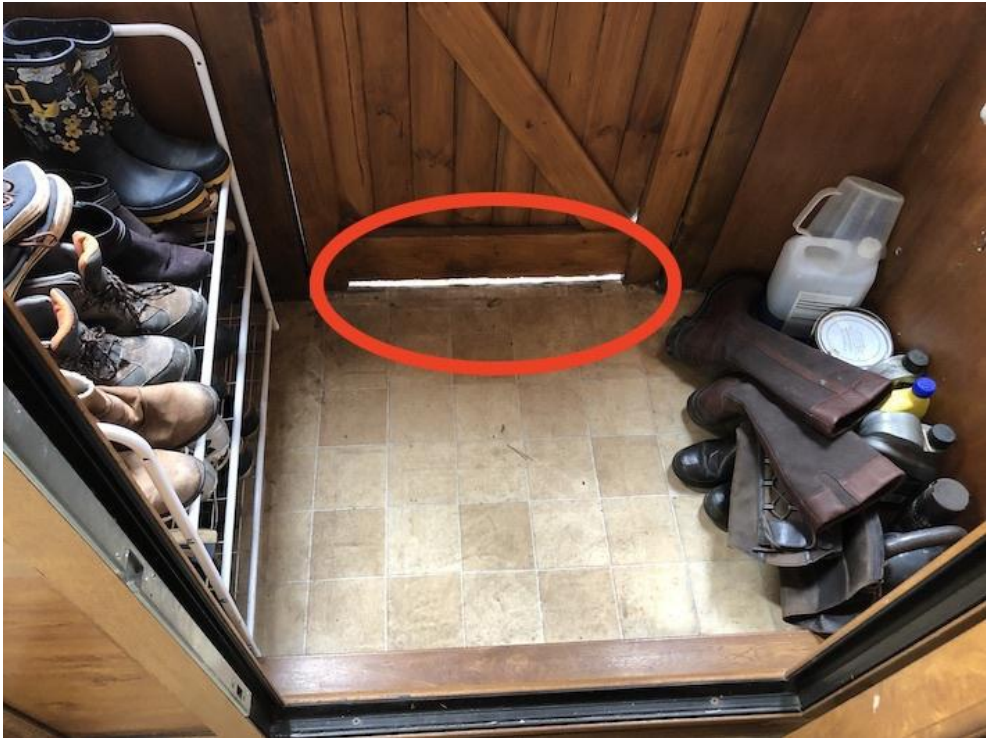
Front door higher than threshold

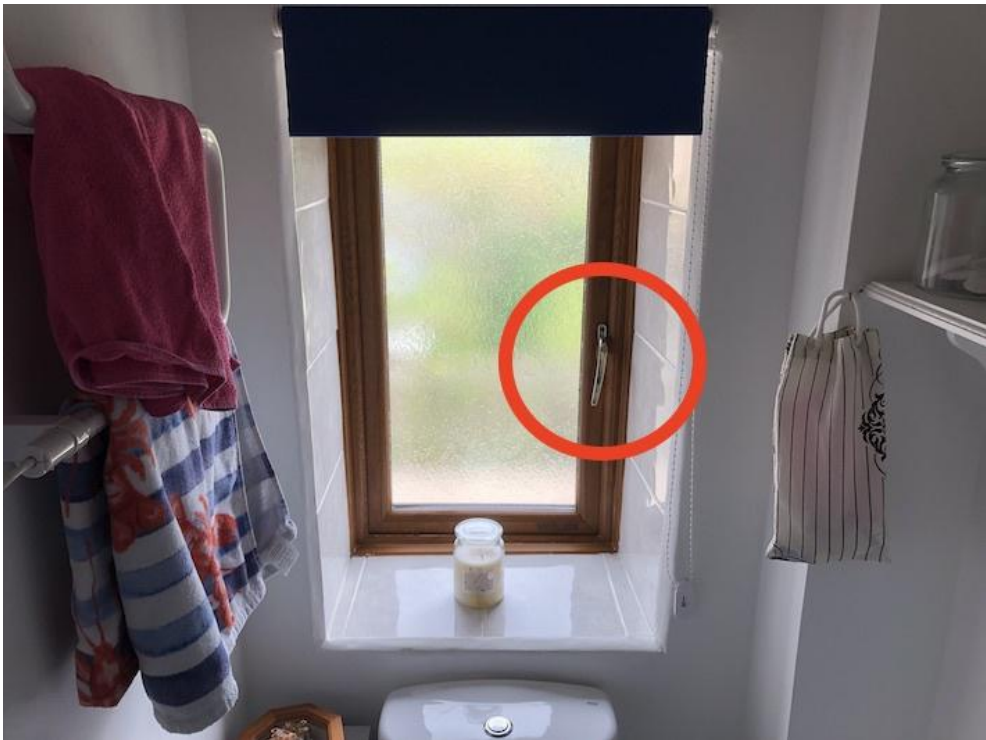
Ensuite window handle loose

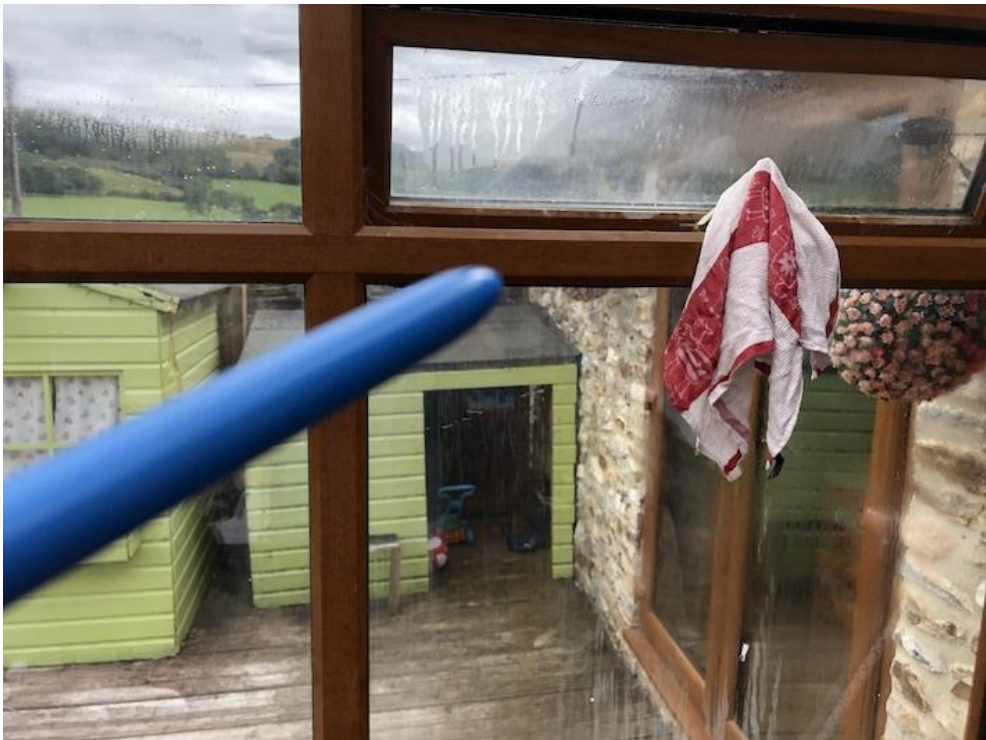
Boot room missed glazed unit example

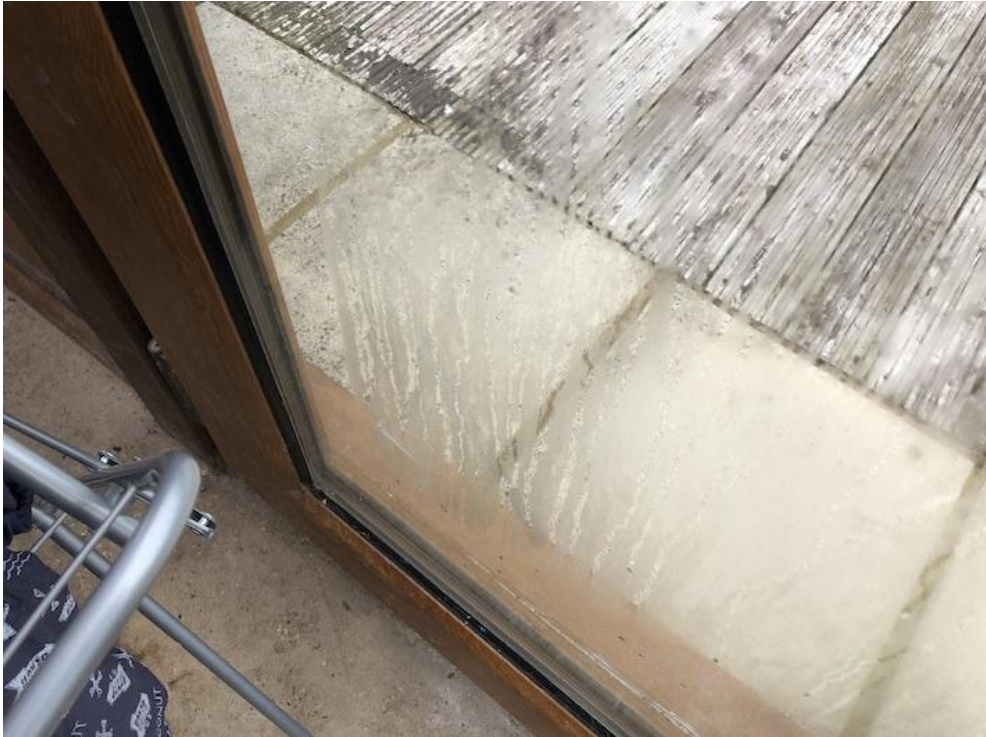
Boot room door unit misted

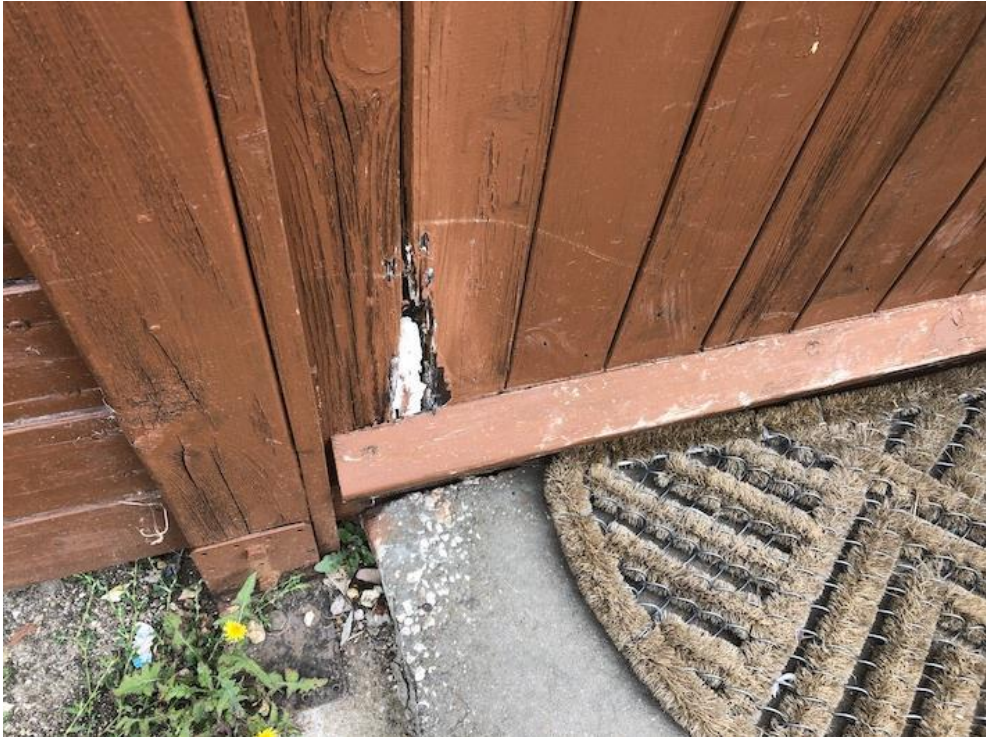
Front door rotten timber

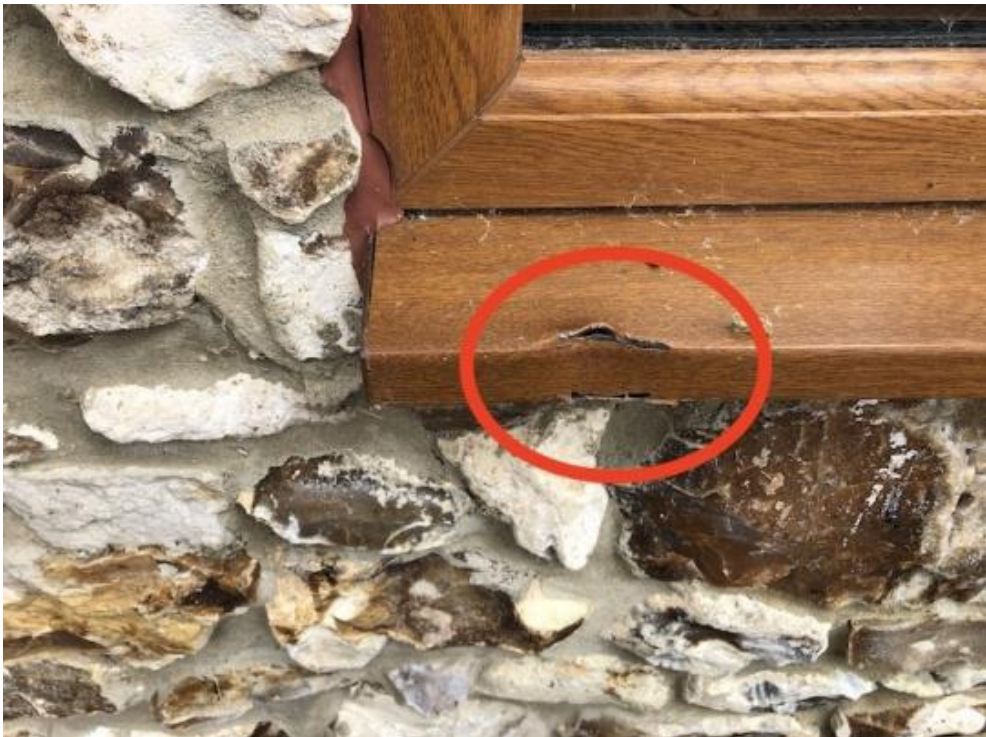
Front left window cill damage

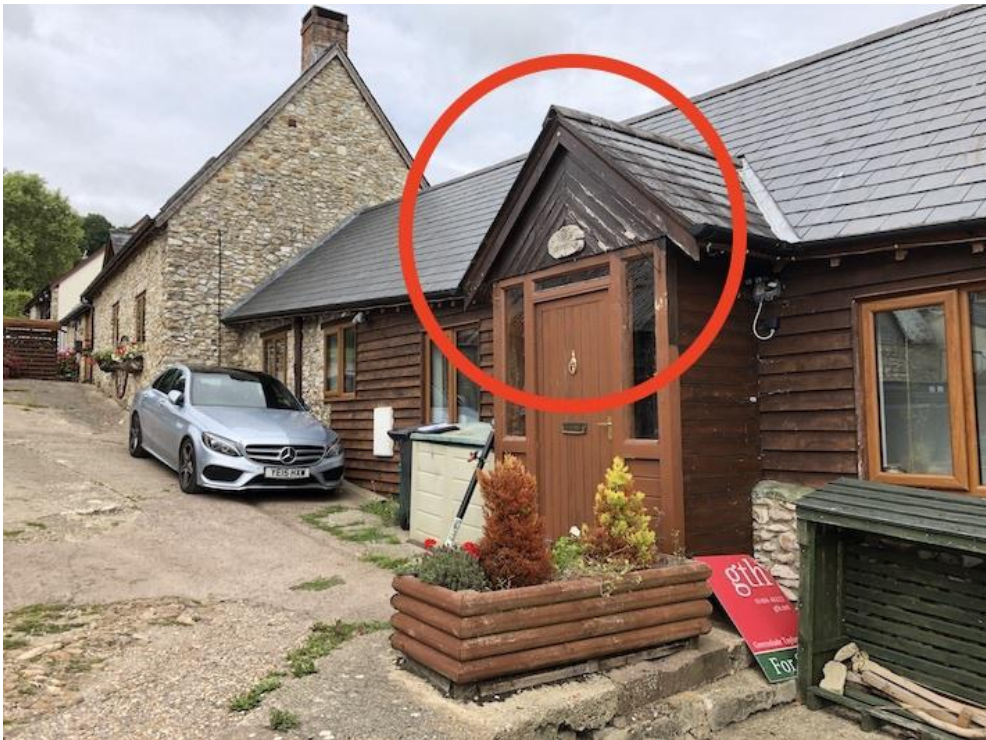
View of porch structure

Action Required	<p>The timber to the front porch needs extensive repair and several timbers require replacement.</p> <p>The outside timber area to the property require maintenance, redecoration and sealant replacement to window/door joints.</p> <p>Regular maintenance will be required especially to the front elevation which faces south/south-west. This section of the property will receive most of any inclement weather and the heat of the sun.</p>

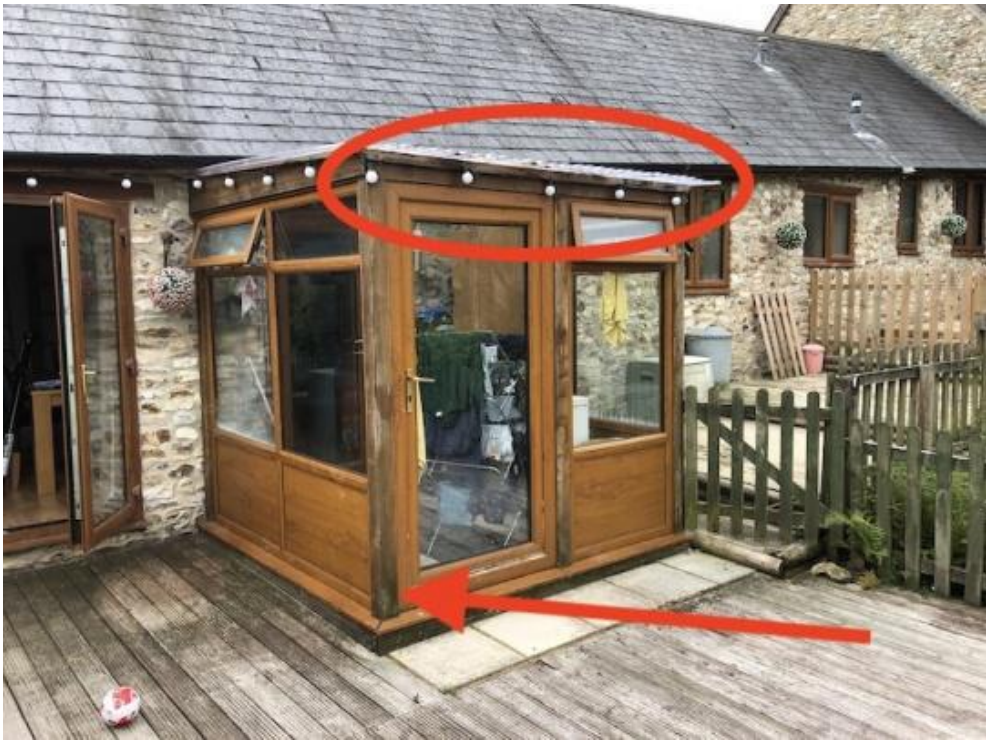
Boot room no gutter and timber defects

Action Required	<p>It is recommended that the front porch be repaired as detailed in sections 4.5 and 4.6.</p> <p>The rear boot room/conservatory needs repair and maintenance to its timber frame and exterior components, a guttering system installed, the blown uPVC windows and door units to be replaced and the roof to be extended or replaced.</p> <p>Regular maintenance going forward needs to include the boot room and front porch.</p>

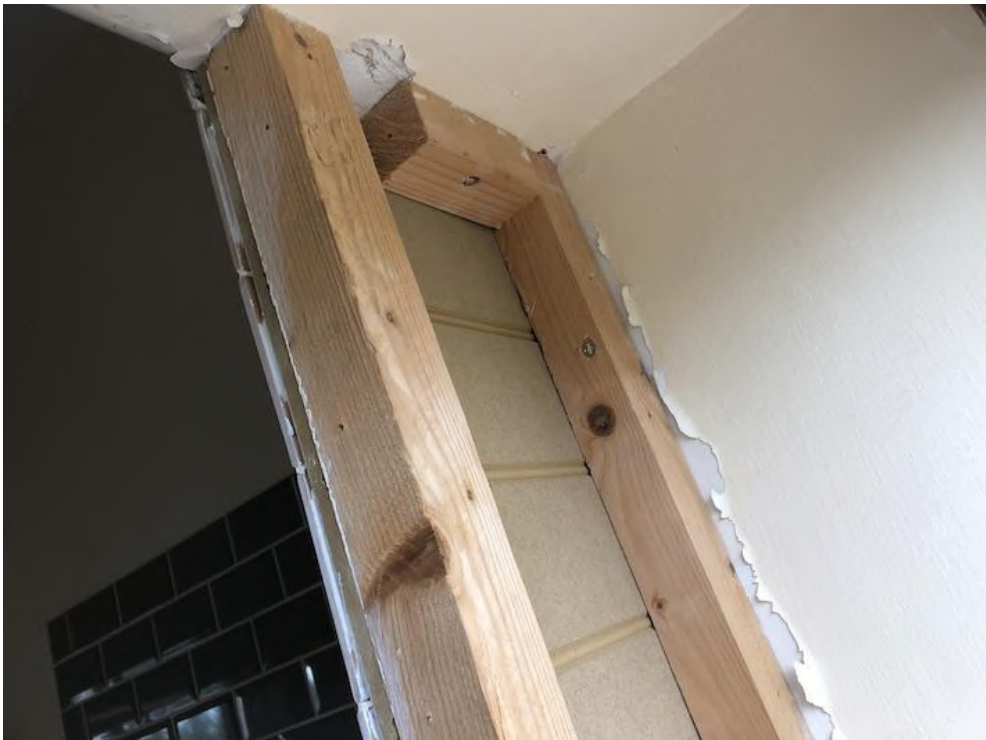
<p>Condition</p>	<p>Generally no significant defects were noted during my inspection and the internal walls were found to be structurally sound. However the rear wall of the bathroom has been extended to the right and in front of the window, this extension has been completed in timber stud and overlaid with tiles, however the extension has been poorly executed and not finished off professionally. The timbers to the rear of the extension are visible and the adhesive for the bath tiles is decaying and breaking up.</p> <p>No evidence was seen of any cracking which might indicate that the property is subject to subsidence or unusual settlement.</p> <p>All moisture meter readings recorded around the property were found to be within a normal range indicating that, in those areas that could be accessed, it is not affected by rising or penetrating damp.</p> <p>Internal walls are well maintained and surface finishes are in a serviceable condition. Some general unevenness was noted. This is due to normal disturbance of the surface by decorations, minor repairs and fittings having been attached in the past.</p> <p>Some cracking of the internal walls can be noted in a variety of locations, primarily on the inside faces of external walls. It is common for cracking to occur as the materials of the building expand and contract during normal heating and cooling. Often this cracking is focused on the weakest areas of the walls which are the openings of, such as windows and doors. Commonly cracking is found around the top corners of windows and doors in the area where a supporting lintel is built into the structure. This occurs because the expansion rate of the lintel differs from that of the surrounding masonry.</p> <p>At the time of the survey no undue levels of cracking were noted.</p> <p>Some of the internal walls are dry-lined or of timber stud construction. This means that special fixings will be required where heavy objects are to be hung onto or attached to the walls as the plasterboard facing of the walls is not sufficiently strong to carry heavy weights. It will also be the case that picture hooks and other nailed-in fixings will only have a light hold within the wall facing.</p>

Bathroom shower wall unfinished

<p>Action Required</p>	<p>The wall at the rear of the bathroom should be completed and finished off to a professional standard. The adhesive to the tiles needs an end bead, or similar, fitted to prevent moisture ingress as well.</p> <p>As part of the legal process, your legal adviser should contact building control at the local council and obtain any records of any notifiable works completed, including removal of internal walls.</p> <p>Normal maintenance is required, including filling and redecorating cracks as necessary.</p>

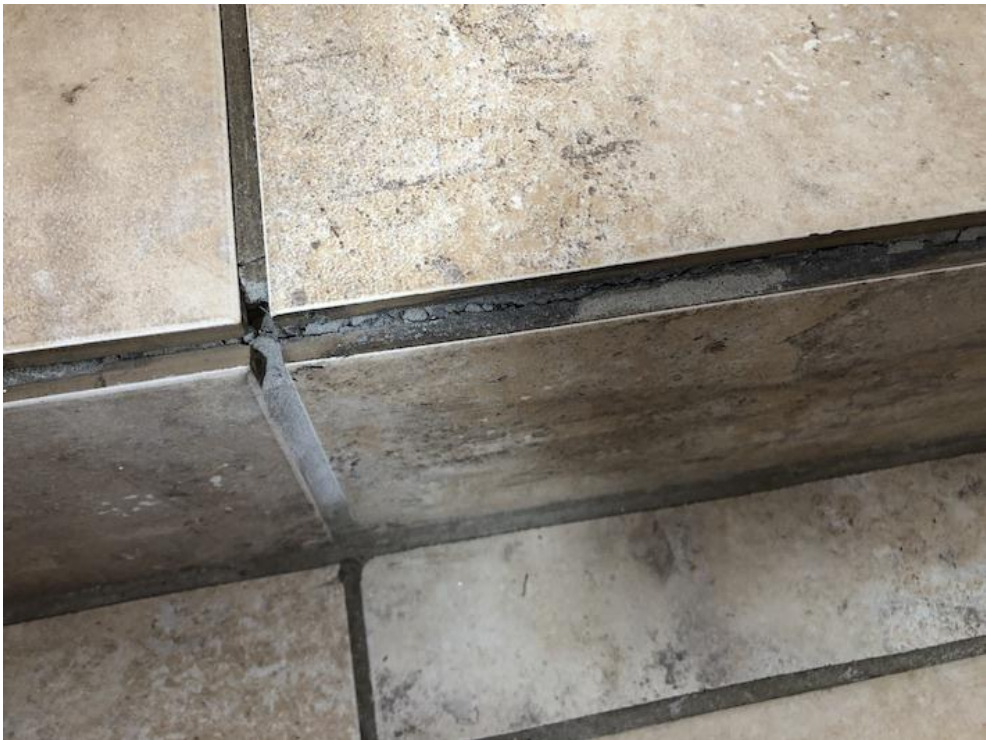
Hallway floor grout

Action Required	<p>The grout to the hallway flooring should be cut out and replaced. Potentially you may wish to find an alternative floor covering solution as grouted tiles on steps have a habit of cracking and failing due to weight distribution changes whilst the steps are in use. This presents as a trip hazard, see section 3.2.</p> <p>Floors should be monitored for any changes that occur in their level or springiness or noise, and further investigations carried out should any such changes become apparent.</p>

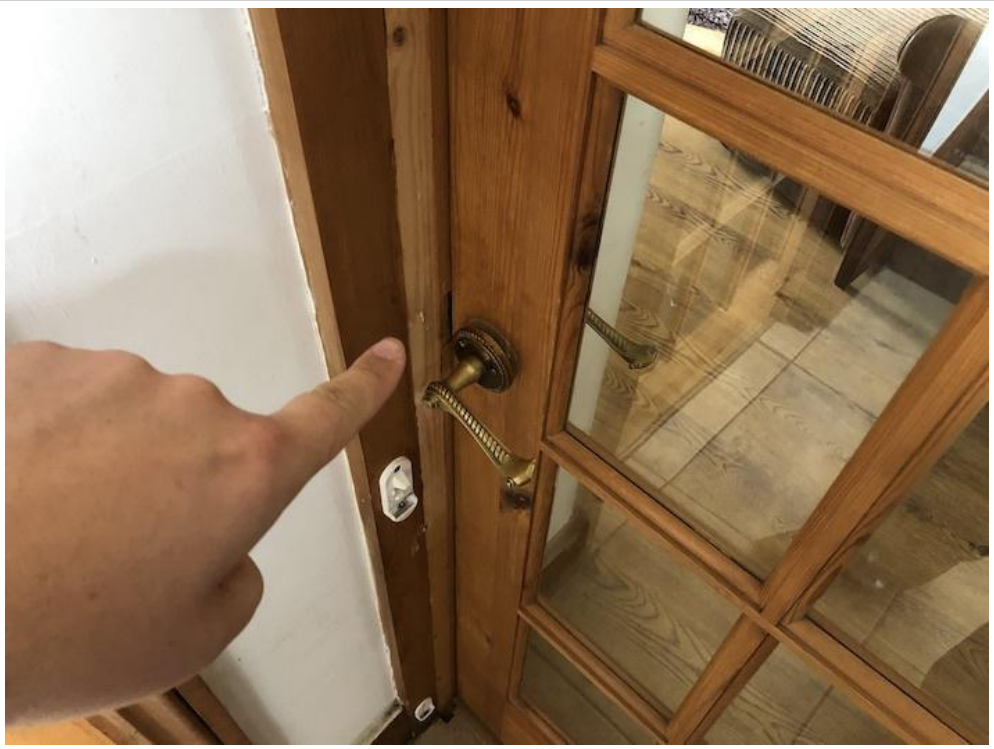
Missing part of door frame

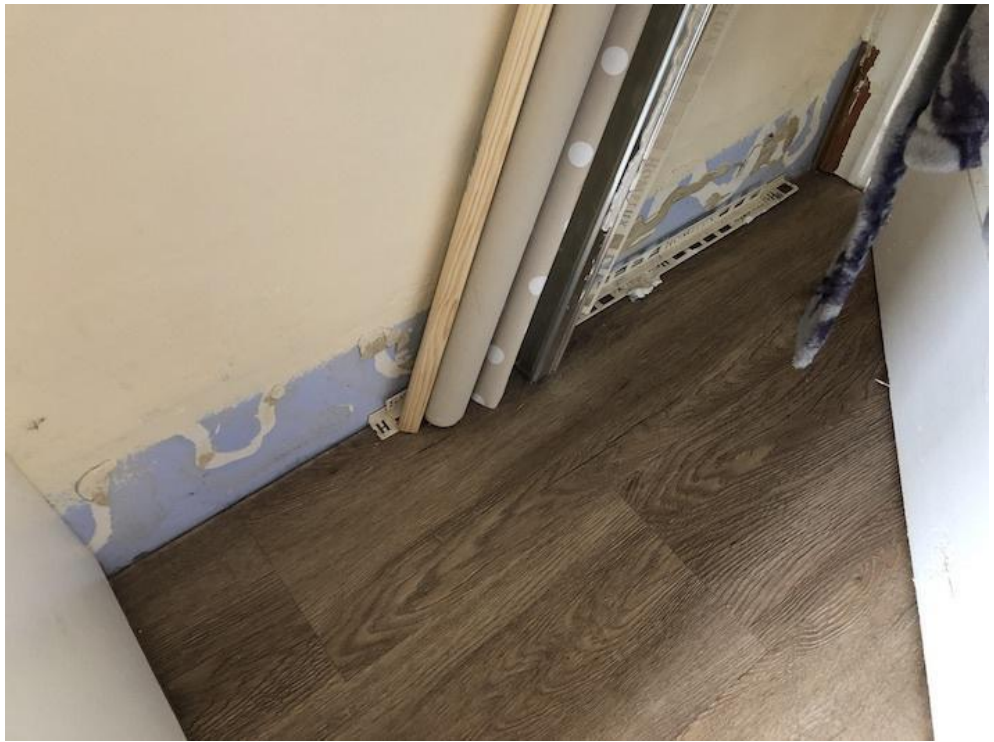
Missing skirting bathroom

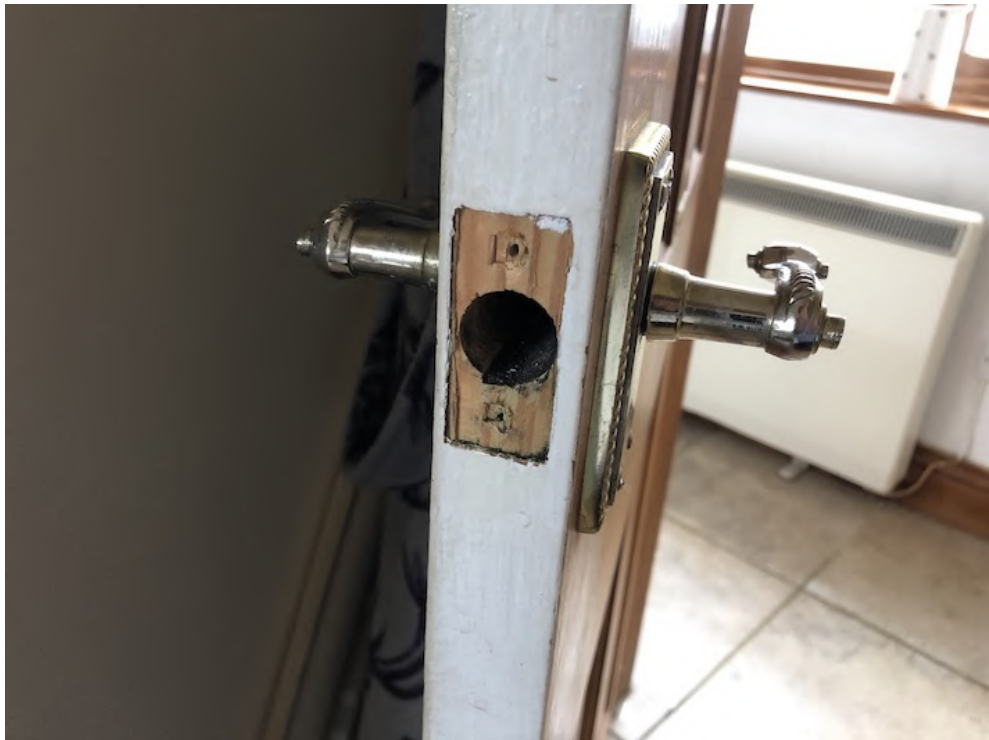
Bathroom missing door lock

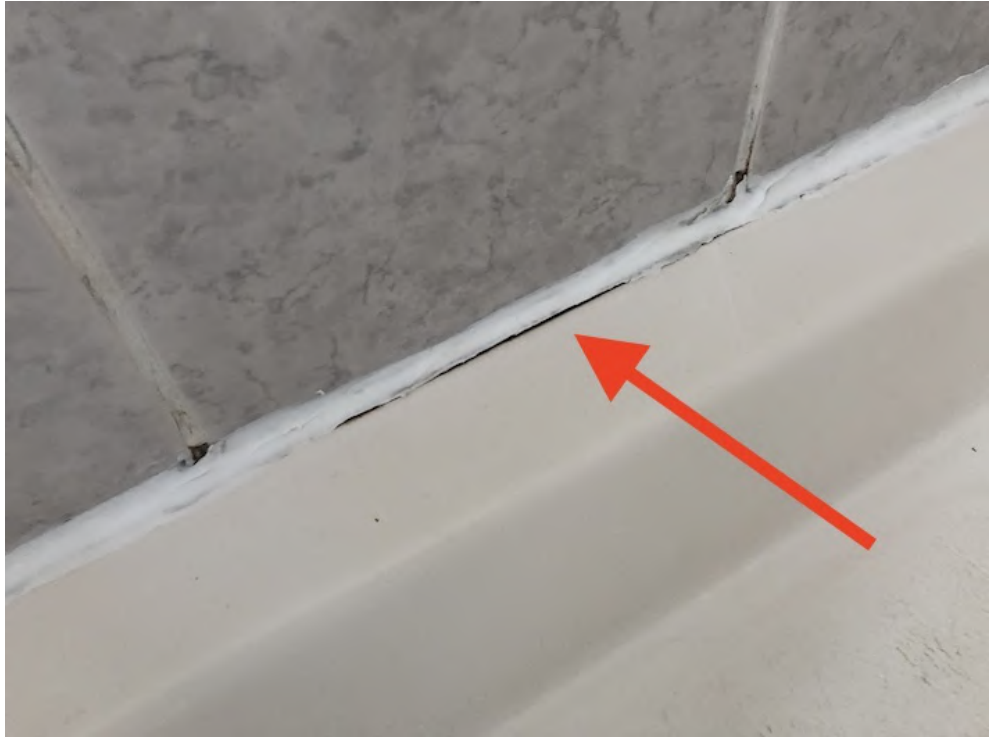
Ensuite shower sealant failed

Action Required	<p>Maintain, repair or replace mechanical ventilation units as necessary.</p> <p>Renew the sealant to the ensuite shower.</p> <p>Regular maintenance of all seals to the bath and shower to prevent water displacement.</p>

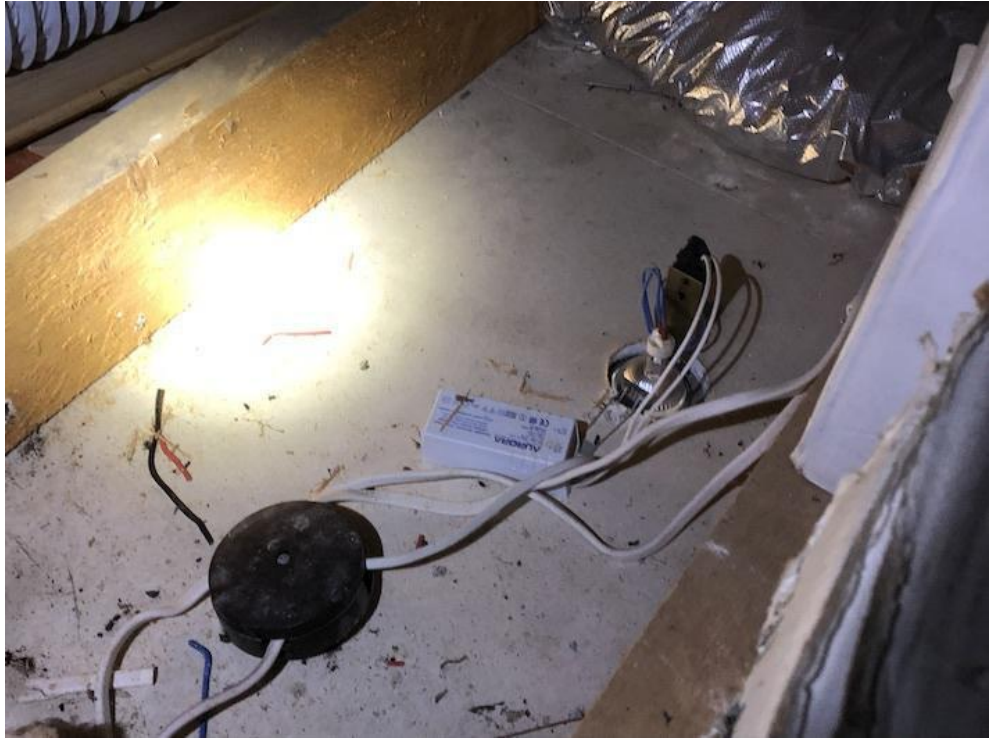
There are no intumescent (fire resistant) hoods over downlights set into the ceiling. When a hole is cut into a ceiling to mount a recessed downlight, a potential fire hazard is created as the hole can allow fire to spread unchallenged. Some downlights are fire rated to protect against the spread of fire in this way, but older types are unlikely to be of this design. In such circumstances a protective cover, known as a fire hood, is installed over the light within the roof space so as to restore the fire-resistant integrity of the ceiling. It is recommended that you install intumescent covers or fire protected lights.

Downlight no housing

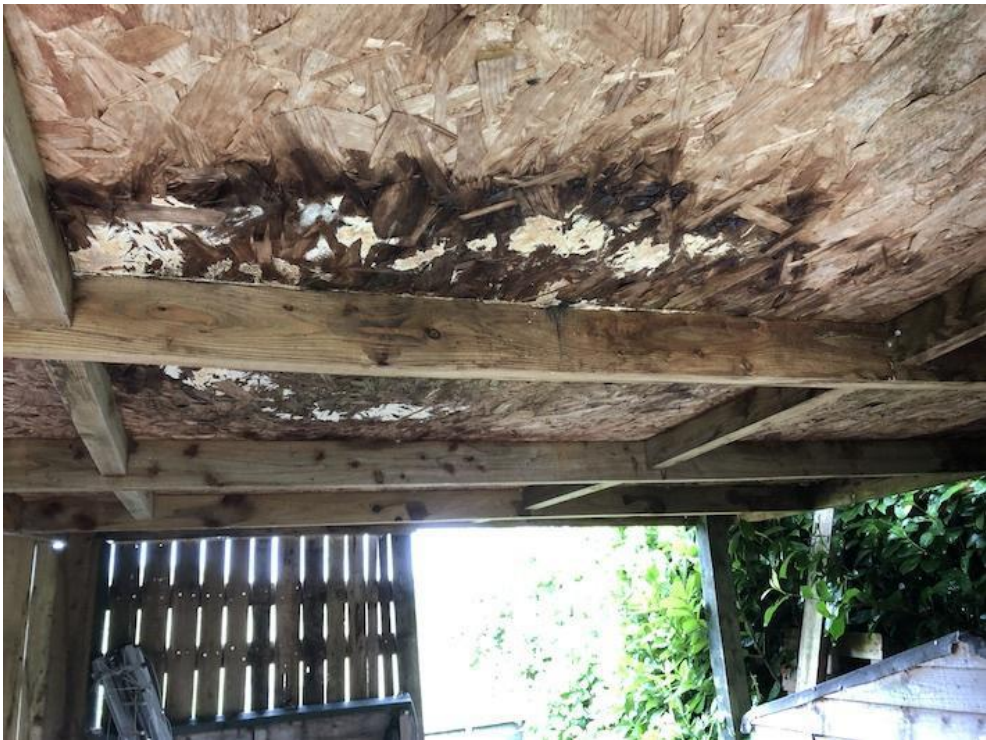
Condition	<p>The shed was found to be in a stable condition with no evidence of rot but is in need of redecorating as this has failed.</p> <p>The summerhouse was found to be in a stable condition with no evidence of rot but is in need of redecorating as this has failed. The felt roof is failing and starting to delaminate.</p> <p>The open sided shed is suffering decay and sporadic areas of timber rot, the decoration to the frame and boarding has failed. The underside of the roof shows a large water stain where rain water is penetrating the felt roof and damaging the deck (roof underside) as a result of this.</p>		
Action Required	<p>Normal maintenance, including regular re-treatment of the timber, is required to all three structures. Areas of rot need to be treated and/or replaced in the short term. The open sided shed is particularly run down and you may consider replacing this upon taking occupation.</p> <p>The felt roofs to the summerhouse and open sided shed need repair or replacement. Compared to traditional coverings such as tiles and slates, most felt roofs have a typical life of 10-25 years. They are also prone to sudden failure and leakage. Periodic re-covering will therefore be necessary. When this is undertaken, the supporting structure may also need some attention.</p>

Open shed roof damage
