BUILDING SURVEY REPORT

The format of this Mi BUILDING SURVEY REPORT is consistent with the guidance note requirements for a Survey Level 3 as defined by RICS Surveys of Residential Property 3rd edition May 2016

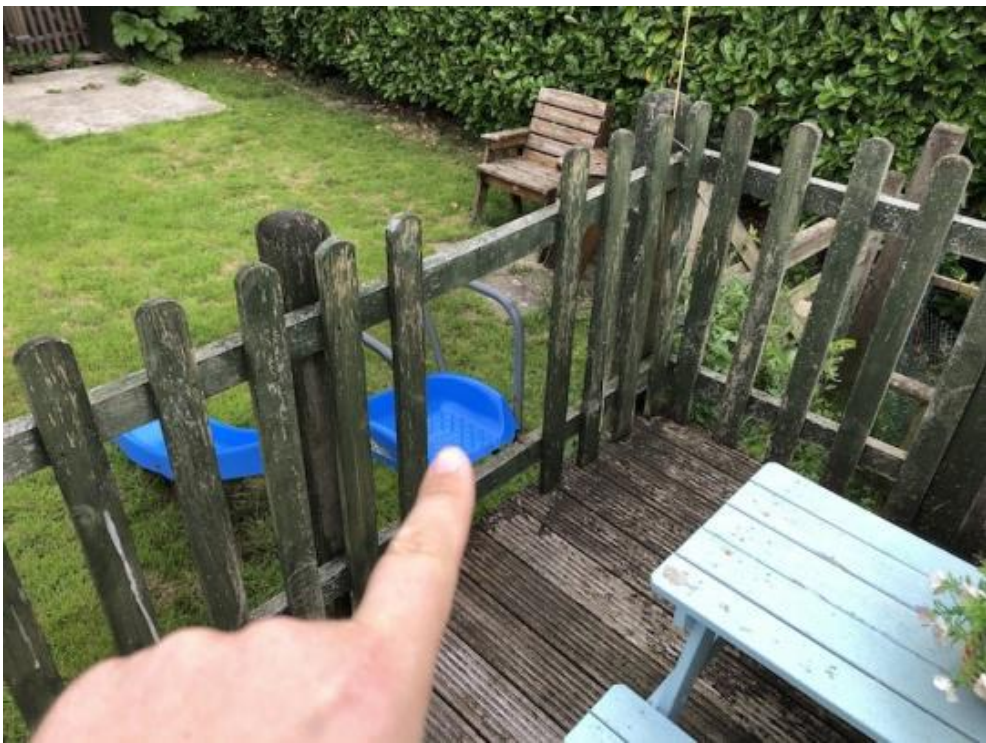
Decking fence hole

<p>Action Required</p>	<p>The items identified in the condition box above all need repair or replacement.</p> <p>The replacement or part replacement of the deck, considering it is raised more than 30cm off ground level, may require planning permission.</p> <p>Once the grounds are brought back to a fair condition then regular maintenance is required going forwards.</p> <p>As previously noted the apparent allocated parking spaces are not listed on the land registry title plan and as such your conveyancer needs to confirm title, rights of way, easement, location and any ongoing maintenance fees associated with the parking spaces. It should be further noted the parking spaces are in a similar condition to the private main access road (see section 7.4), basically requiring full resurfacing and levelling.</p>

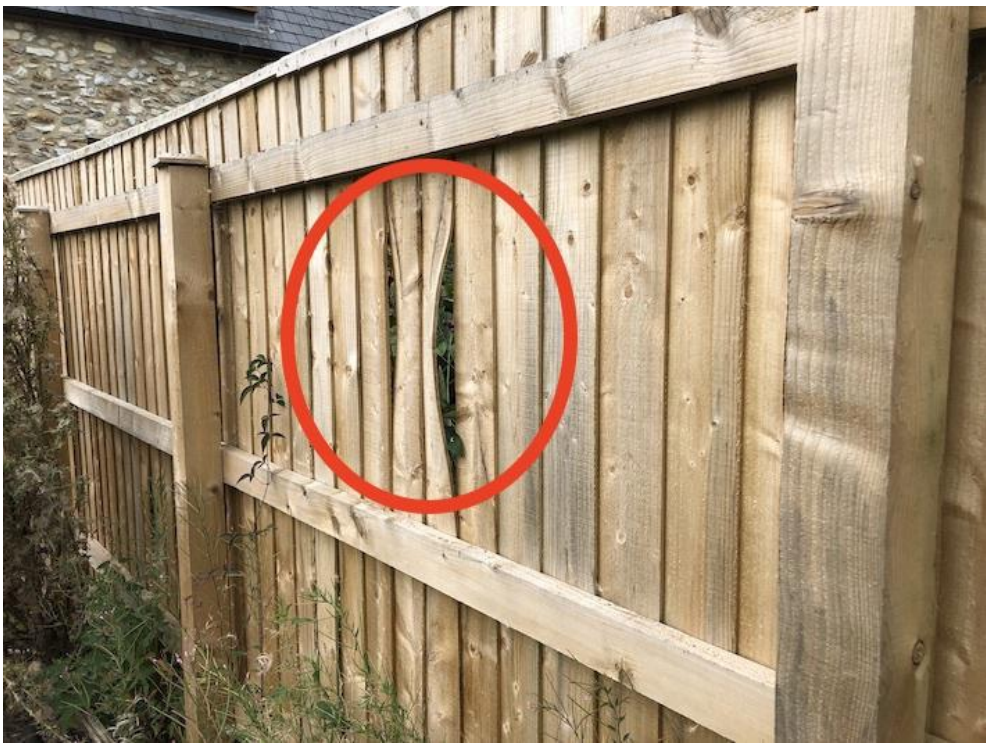
Rear left fence damaged

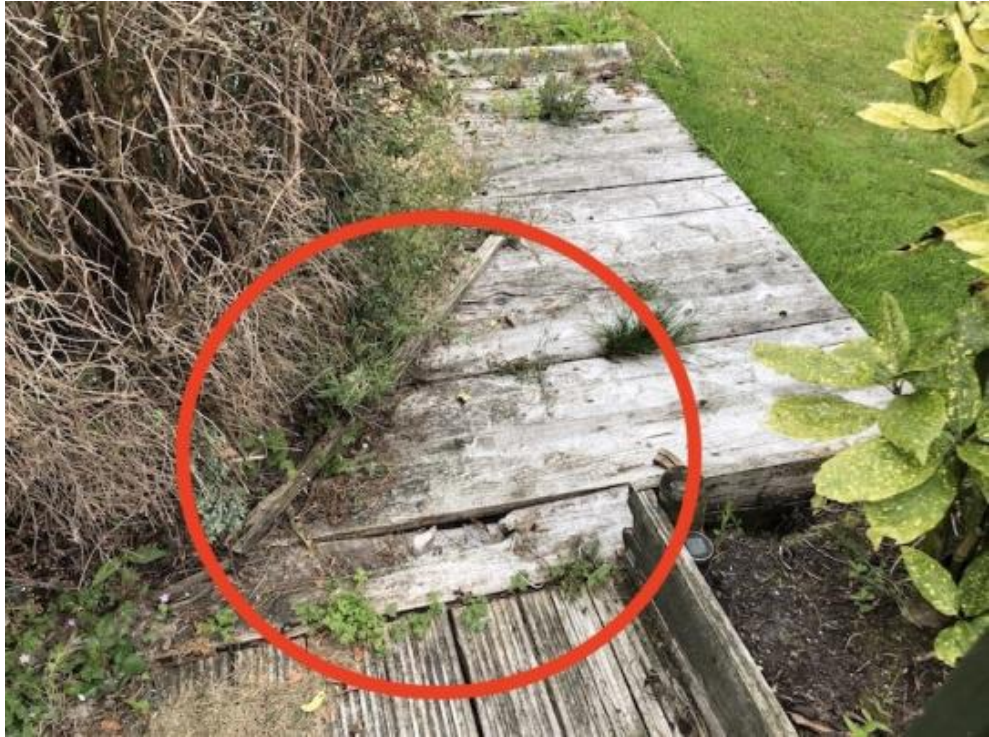
Rear left decking rotten
