Home Condition Survey

Report Reference No: [REDACTED]
Produced for: [REDACTED]
Date: 31-Aug-2020
Surveyor: Mr David Clare

Type of property	The property is a detached house.
Tenure (legal advisor to check)	Freehold
Approximate year when property was built	2004
Approximate year the conservatory was built	2006
Weather conditions at the time of inspection	Dry, warm day, circa 20c with a clear sky.
The condition of the property when inspected	The property was occupied, fully furnished and habitable.
Is the property subject to special planning restrictions?	No.

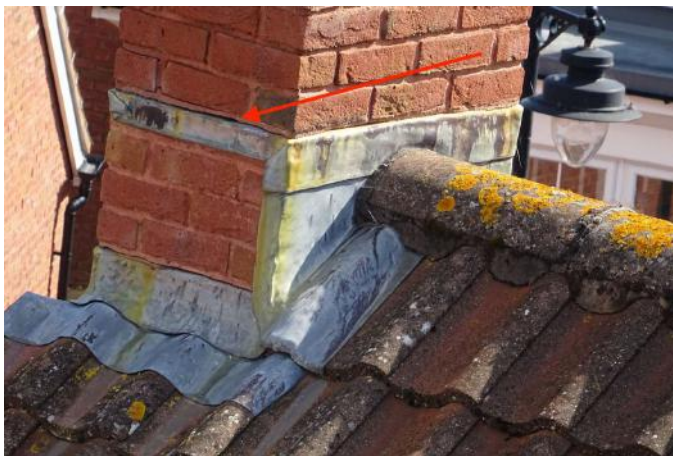
Right chimney mortar cracked

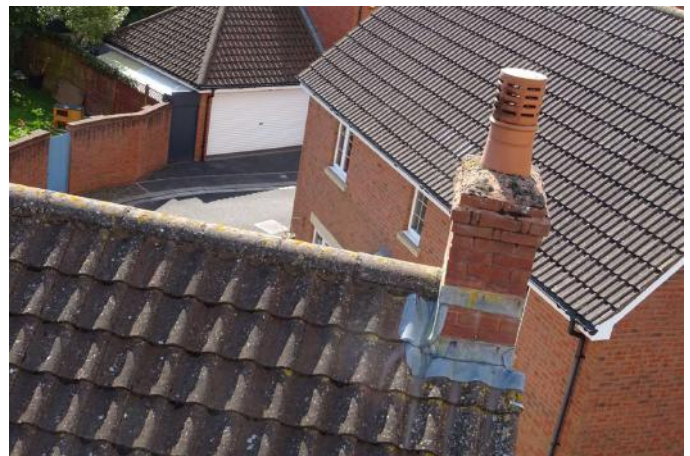
Left chimney moss

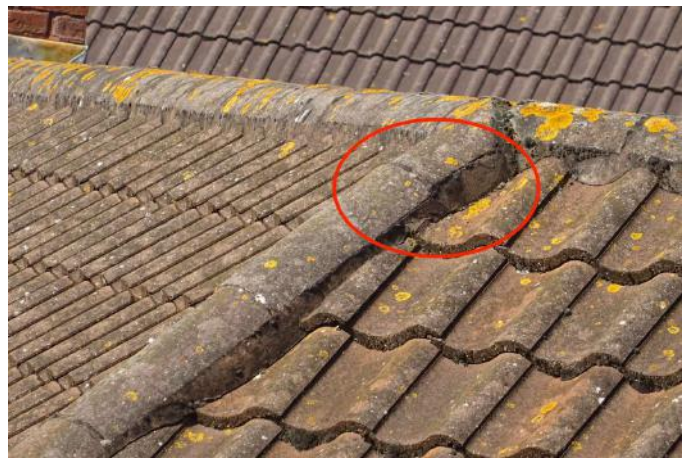
Front hip mortar decay

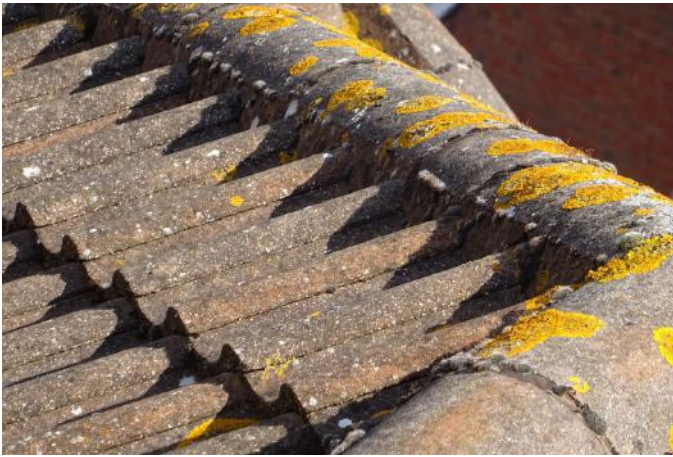
Lichen on ridge

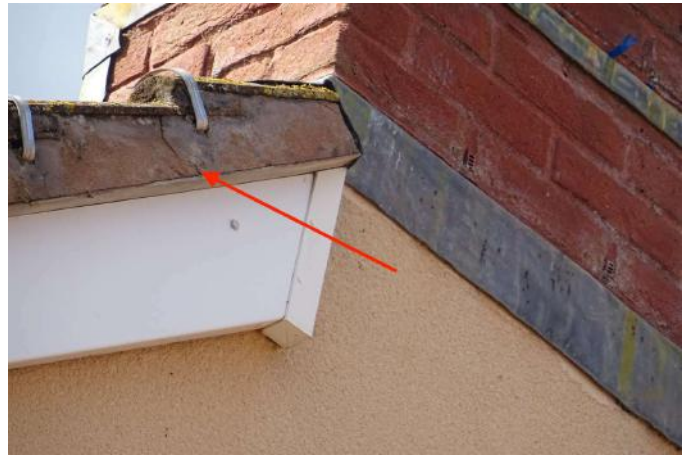
Right verge mortar cracked

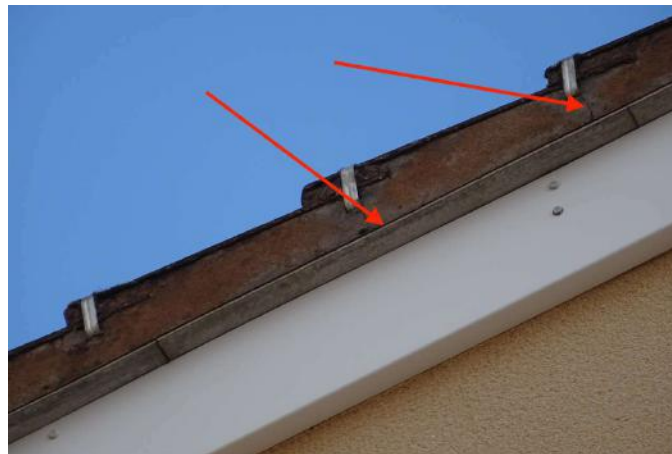
Left verge mortar cracked

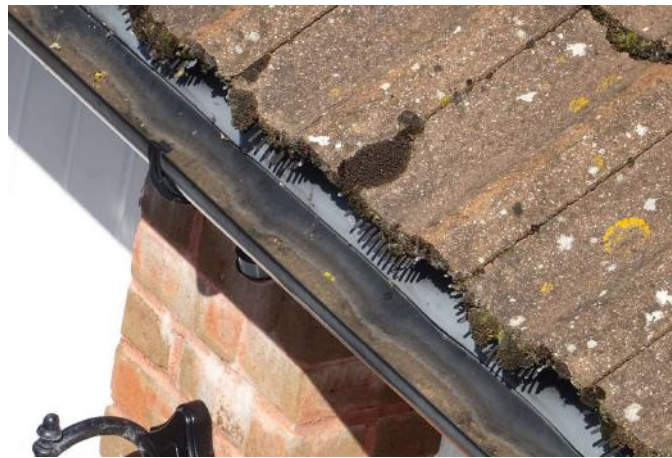
Gutters are generally in acceptable condition, with some minor holding of water and light debris in the channels which can be adjusted and cleared out during regular maintenance.

Gutter debris

It is essential that the gutters are kept free of debris, such as leaves, as this can prevent proper draining resulting in rot and decay to other parts of the building.

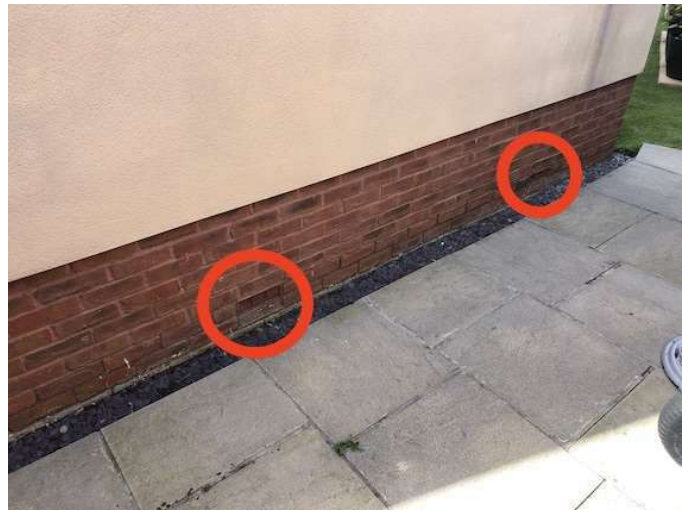
Air vents

You should look to add extra sub floor air vents to promote cross flow of air to the sub floor void.

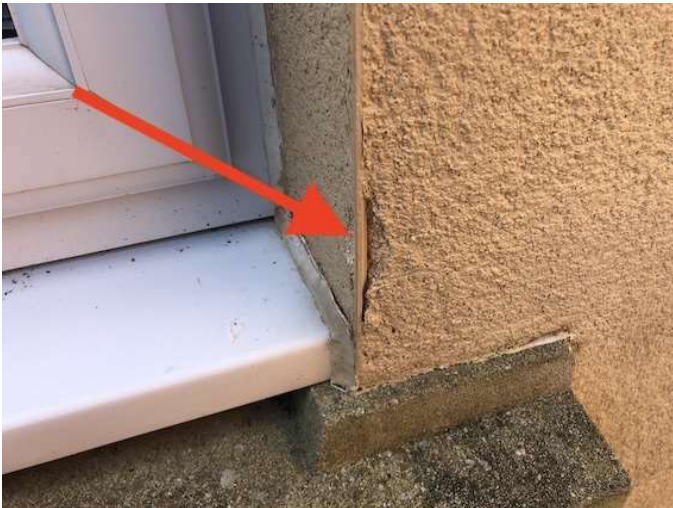
A small area of render is damaged on the ground floor right gable window surround and a small vertical crack is found on the front elevation at the joint where the property bends in half.

Damaged render

The render, where damaged, should be patch repaired.

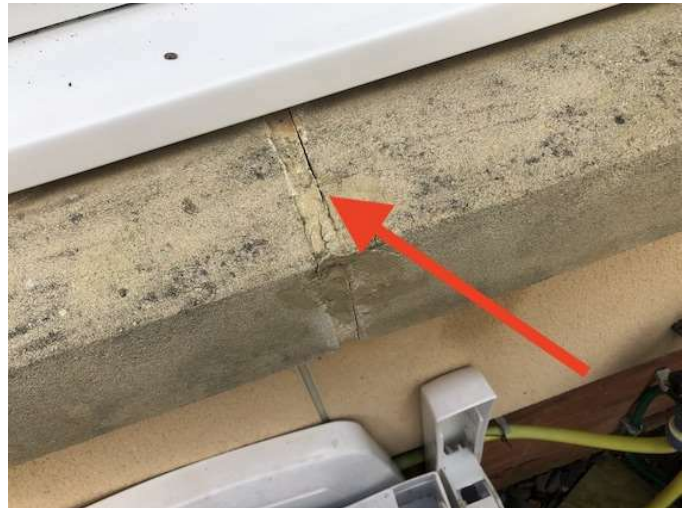
Some of the window cills on the outside of the property have cracked or have decaying mortar joints.

Window cill mortar cracked

The mortar joints of window cills should be raked out where cracked or decayed and repointed.

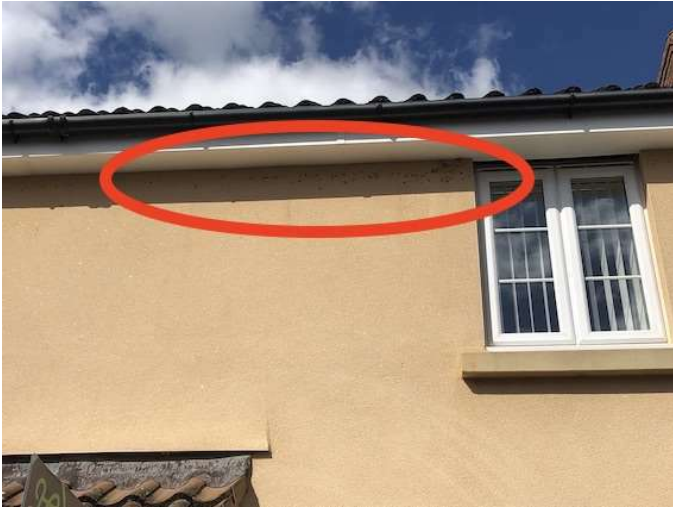
Birds have nested at the front of the property near the eaves and this has stained the render.

Front elevation render bird nest stained

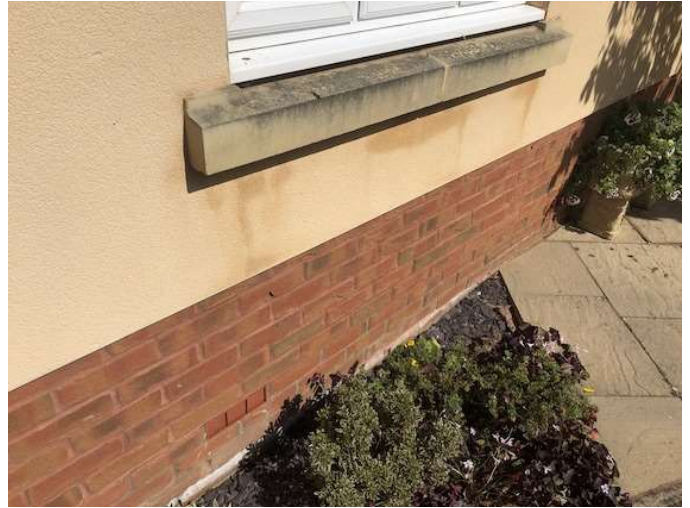
Render stained

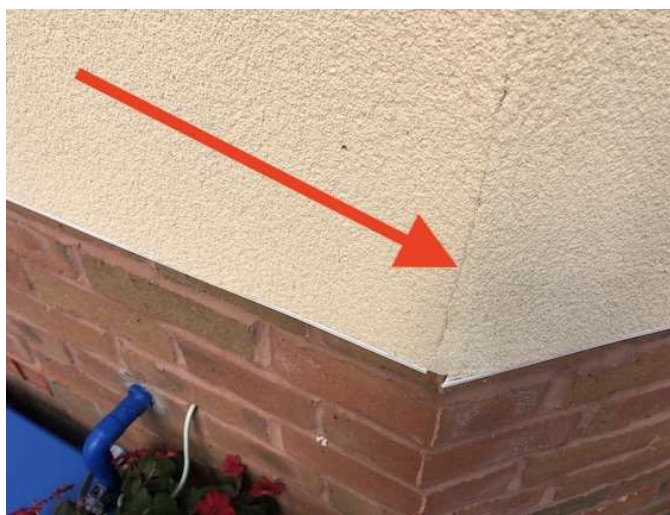
Render cracked

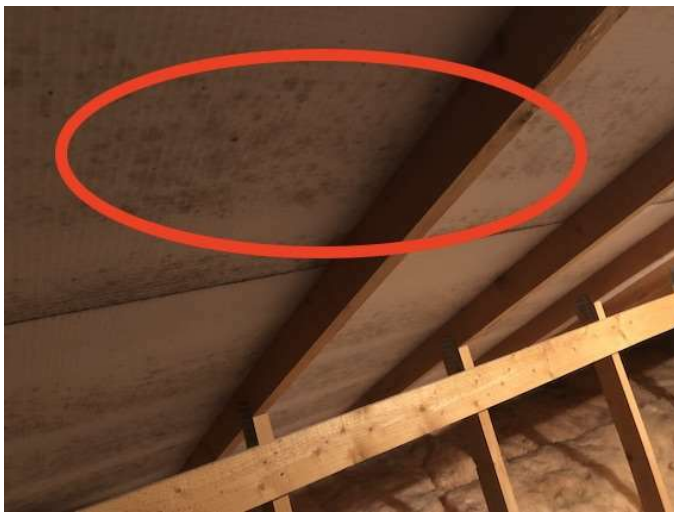
Underfelt mould

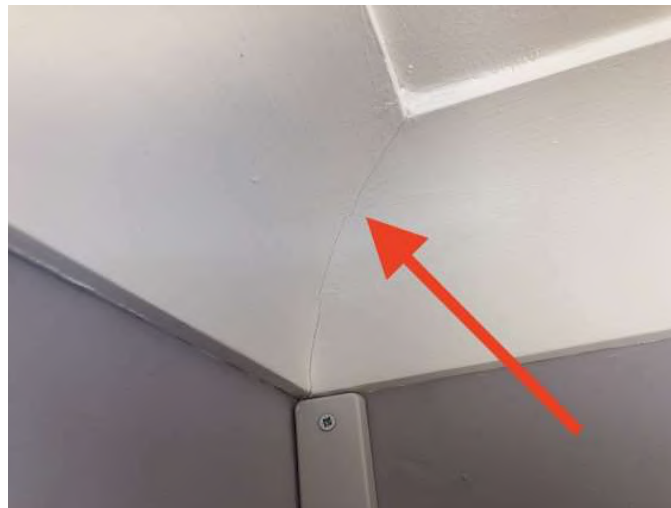
Some ceilings display minor/thin cracks which follow the joints of the boards. This type of cracking is common in construction of this type and is not indicative of any underlying fault.

Ceiling thin crack

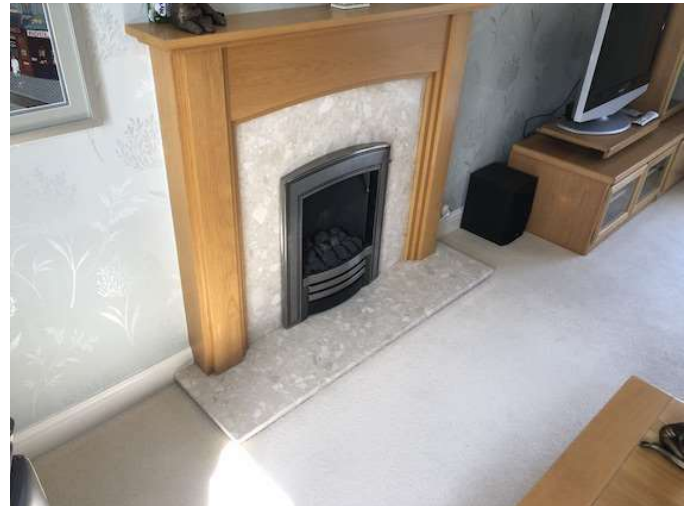
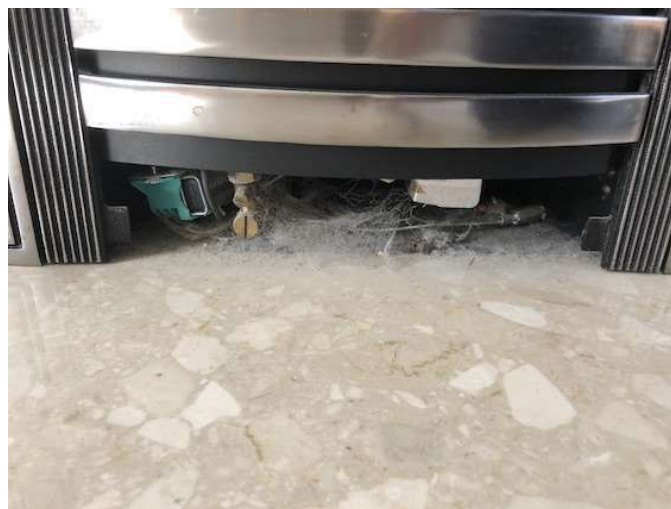
Gas fire

Further advice should be obtained and a Gas Safe contractor should be instructed to test the system and the gas fire and provide a test certificate before occupation.

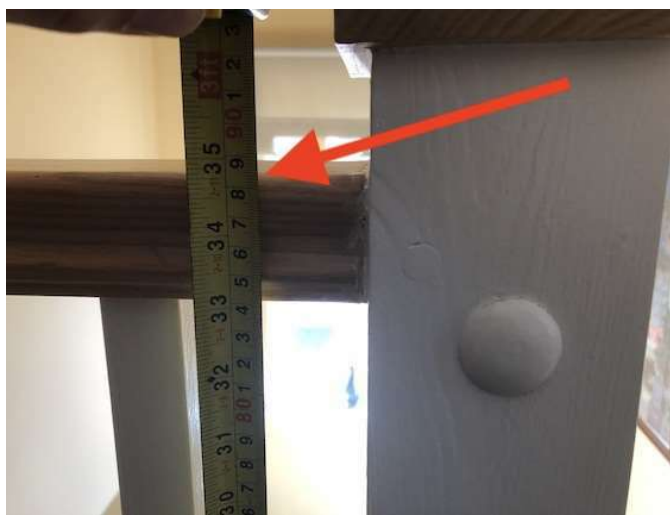
<p style="text-align: center;">Radon</p>
Gas	No specific issue was noted by the surveyor.
Handrails	The position of the handrail on the staircase is a safety risk.
Asbestos	No specific issue was noted by the surveyor.
Unsafe fittings	No specific issue was noted by the surveyor.

Stairs and guarding	The handrail height to the staircase is 89cm off the floor level, to meet current building regulations this should be 90cm.
Insect nests	No specific issue was noted by the surveyor.
Smoke detector	No specific issue was noted by the surveyor.
Roof space partition	No specific issue was noted by the surveyor.
Vermin	No specific issue was noted by the surveyor.
Lead paint	No specific issue was noted by the surveyor.
Ponds and garden features	No specific issue was noted by the surveyor.
Flies	There are a lot of flies (dead and alive) within the loft void. Exterminating of these creatures should take place and nests/food sources removed.

Handrail

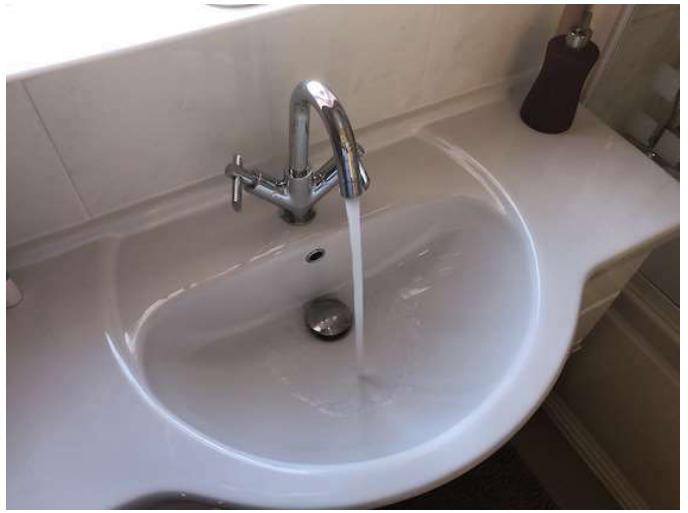
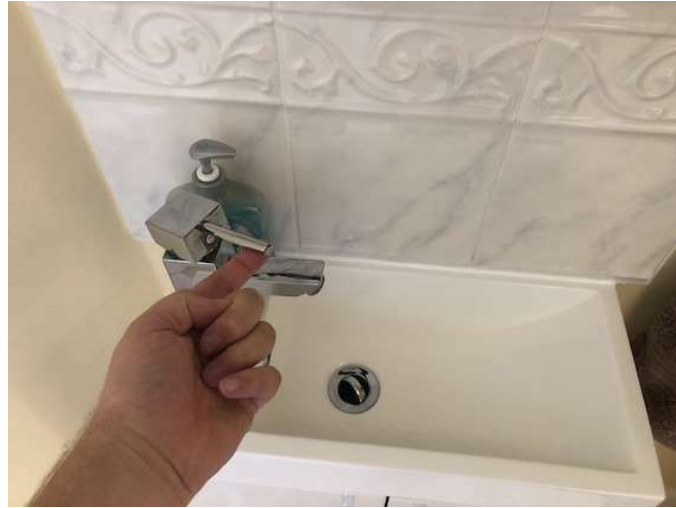
Tap loose

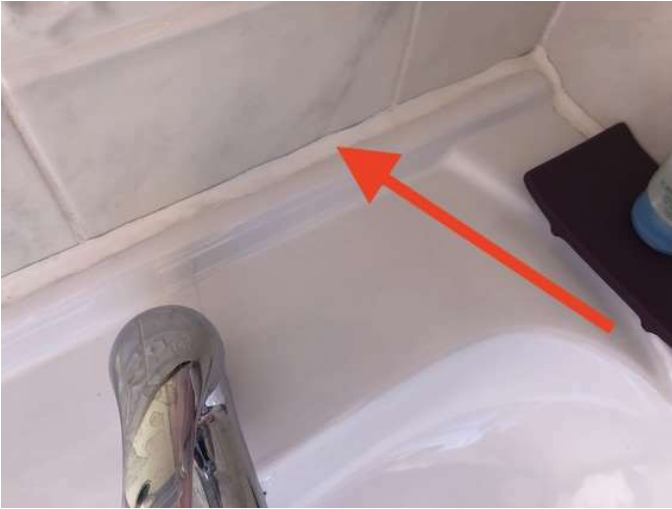
Sink sealant failed

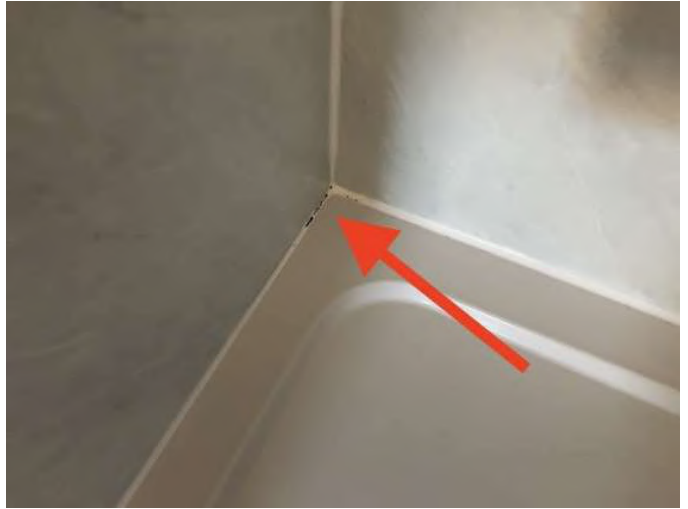
Shower sealant mould

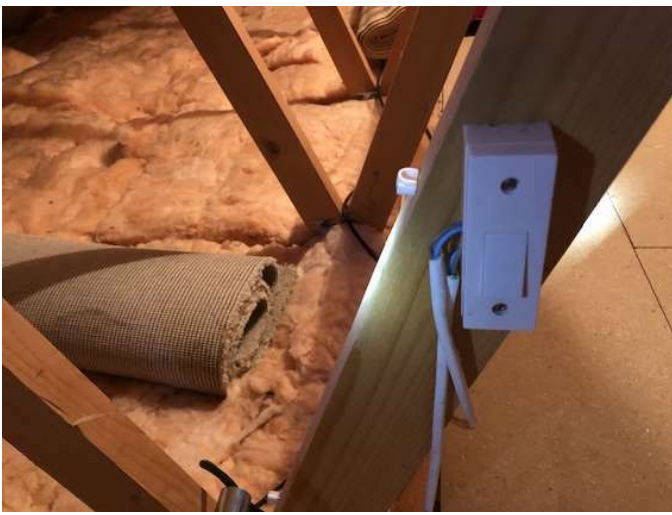
DIY electrics loft

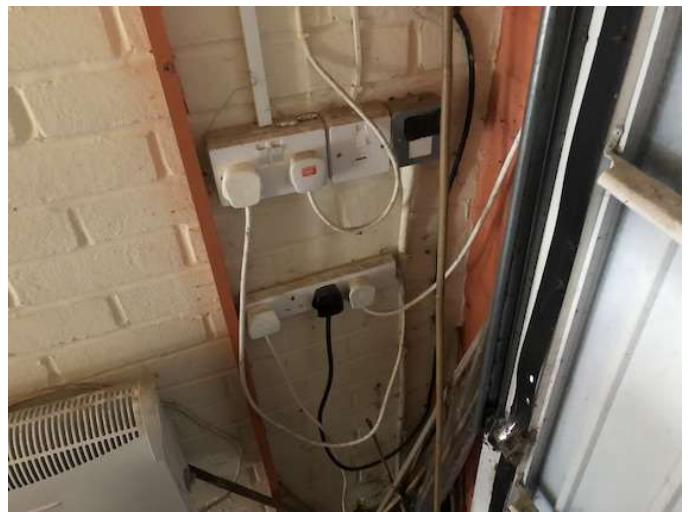
DIY electrics in garage

There are concerns in relation to the electrics in the garage and this is commented upon fully in section F1.

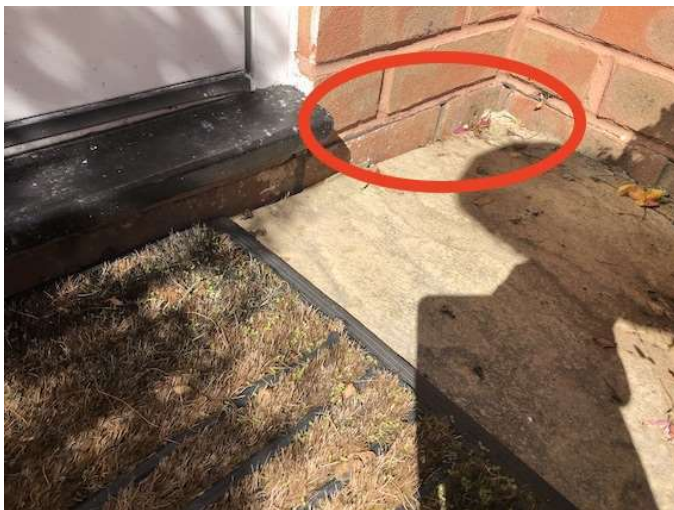
DPC garage issue

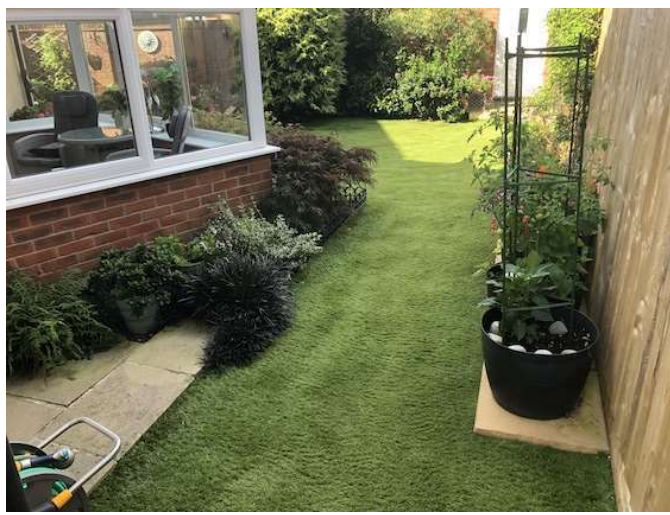
The artificial lawn is not level and flat as it should be, it appears to have sunk in multiple spots, likely due to the sub-base compacting after it was laid. Most new purchasers will want to have the sub base repaired and this may necessitate the artificial grass itself needing to be replaced if it has stretched.

Artificial grass settled

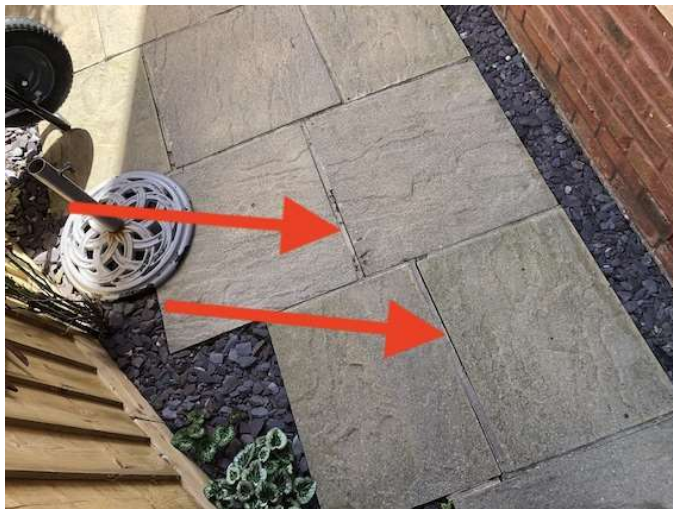
The paving slab areas of the rear garden have sporadic mortar grout failure that needs repointing. In addition the right side patio area slabs are lifted in some areas and require re-bedding.

Patio grout failed

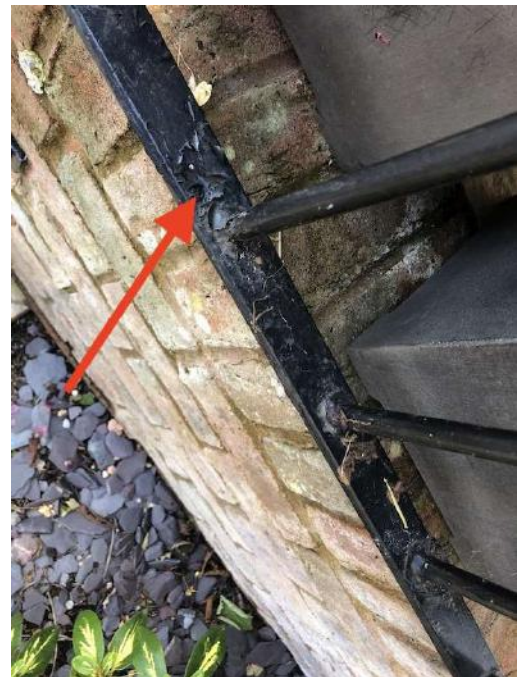
Railings paint failed

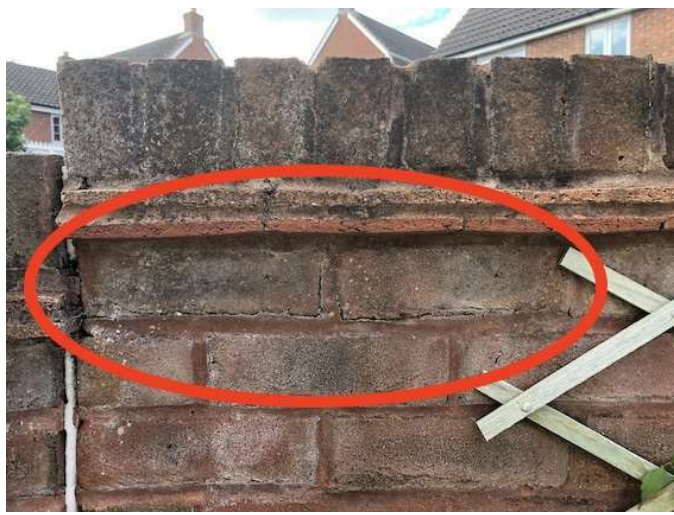
Garden wall mortar cracking
