# New Build Inspection Report

PROPERTY [REDACTED]  
[REDACTED]  
[REDACTED]  
[REDACTED]  
[REDACTED]

REF [REDACTED]

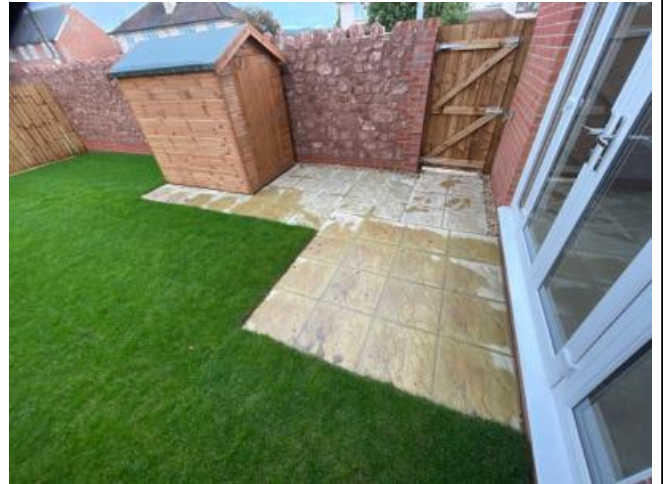
6. Rear garden patio. Timber shed cannot be opened as no lock installed.

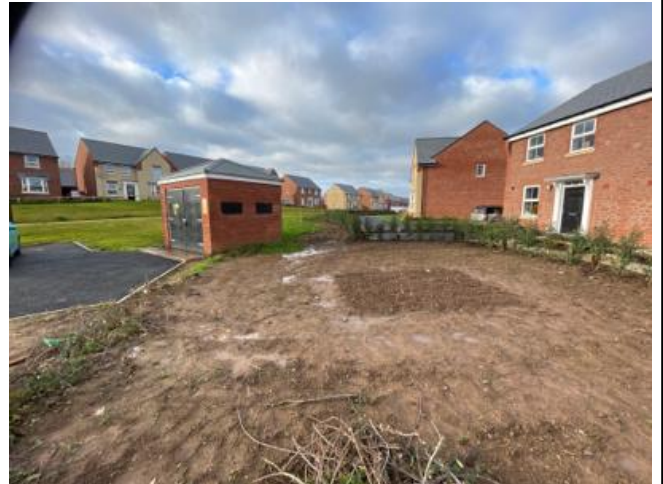
10. Pumping station at front, this may create noise during use, your legal advisor should confirm hours of operation and potential for disturbing you during occupation.

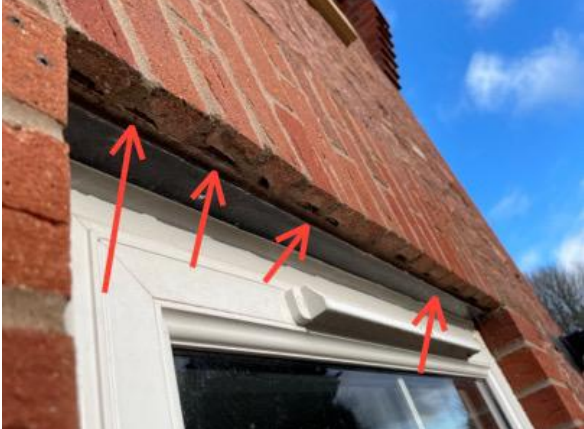
Location / Element	Picture	Comments	Trade
<p>Front Elevation</p> <p>Walls</p>

<p>Ground floor window upper section under soldier course, mortar sporadically missing.</p>	<p>Bricklayer</p>
<p>Front Elevation</p> <p>External Joinery and Finishes</p>

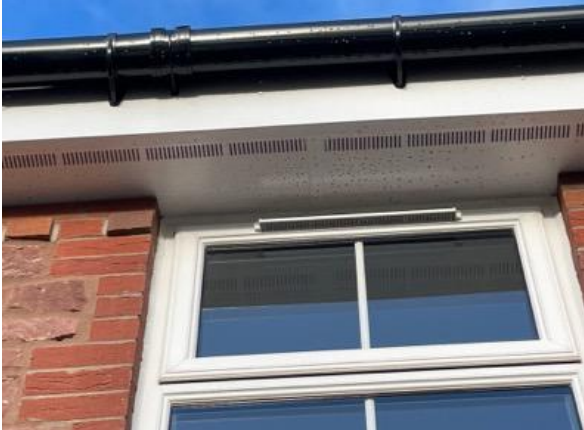
<p>There is building debris and splashback to the underside of the soffits at the front elevation, this requires cleaning.</p>	<p>Cleaner</p>
<p>Front Elevation</p> <p>Windows and External Doors</p>

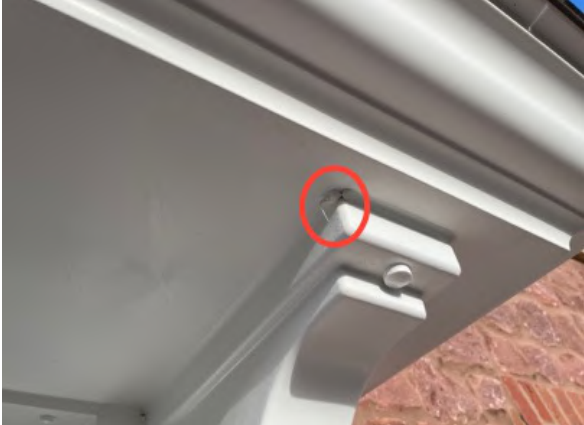
<p>The front door porch canopy on the right hand side has mastic that has been inappropriately applied and to a lesser extent the same is similar on the left-hand side.</p>	<p>Decorator</p>

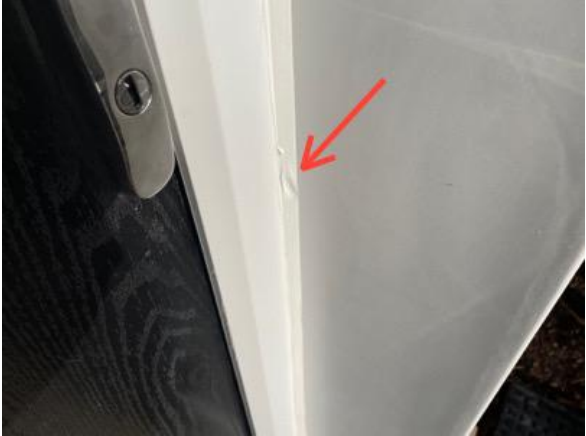
<p>Front Elevation</p> <p>Windows and External Doors</p>

<p>The front door sealant where it joins the upright of the canopy has mastic with finger depressions to it.</p>	<p>Decorator</p>
<p>Front Elevation</p> <p>Walls</p>

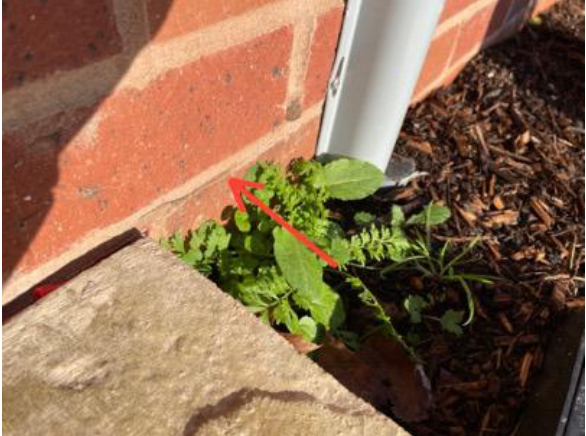
<p>The PVC damp proof course to the property is present however has been breached by mortar for most of the perimeter and this needs to be addressed. Additionally, the ground levels have reduced the height of the damp proof course to less than 150 mm.</p>	<p>Bricklayer</p>
<p>Front Elevation</p> <p>Walls</p>

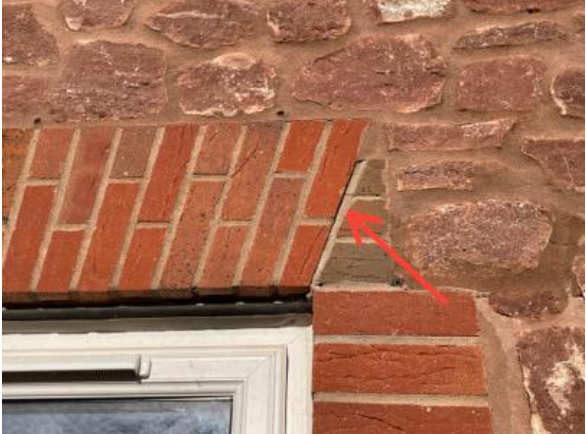
<p>Ground floor kitchen window right side of brick arch has shrinkage to the mortar approximately 20 cm in a vertical length that needs to be repointed. There is a similar issue to the left side of the same arch.</p>	<p>Bricklayer</p>
