BUILDING SURVEY REPORT

The format of this Mi BUILDING SURVEY REPORT is consistent with the guidance note requirements for a Survey Level 3 as defined by RICS Surveys of Residential Property 3rd edition May 2016

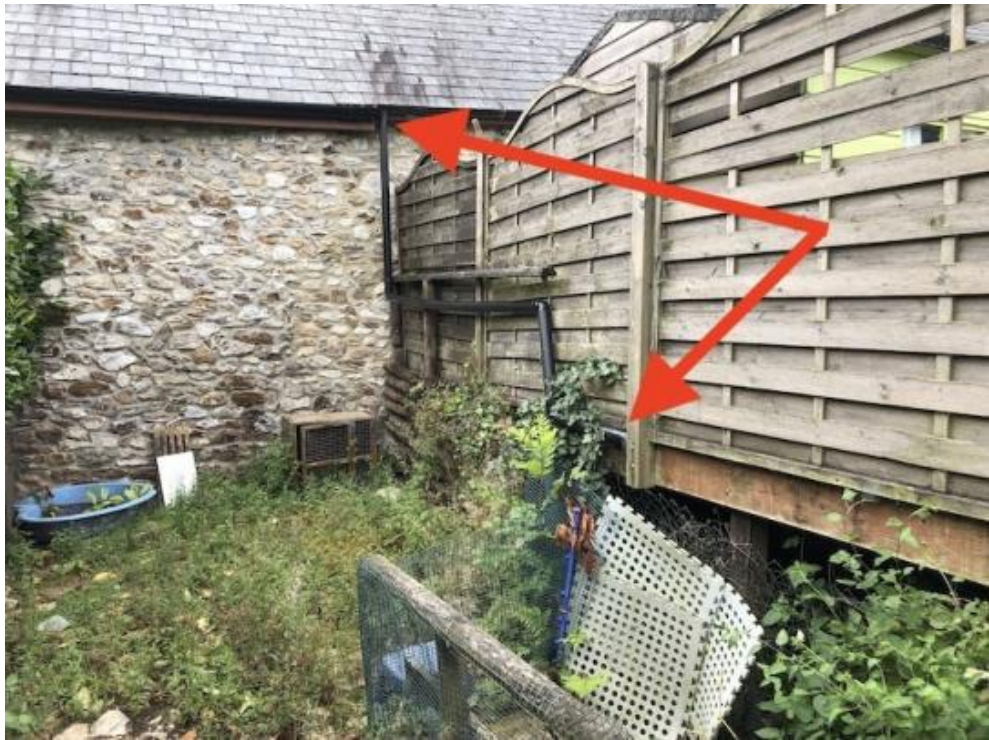
Rear right downpipe

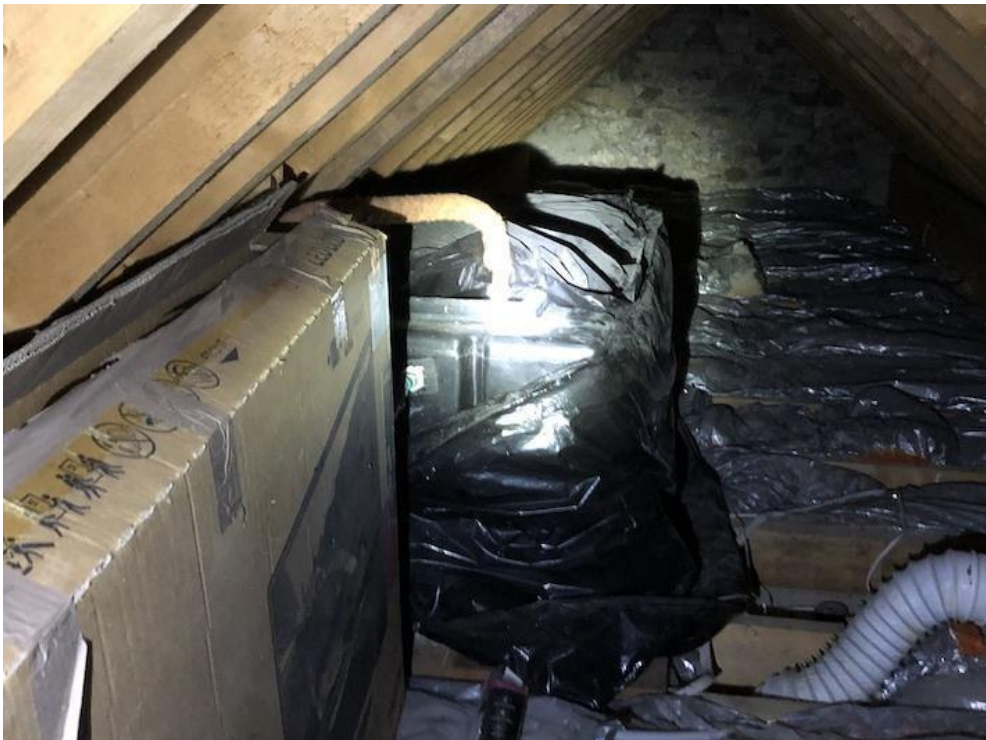
The property could benefit from increasing the depth of insulation to the roof space. Currently there is approximately 150mm of insulation installed. The recommended depth is 270mm. When installing loft insulation it is essential to ensure that good ventilation of the roof space is maintained.

Water tank and loft insulation

Ensure that the cold water tank in the loft is properly insulated and is fitted with a lid. Insulation should not be placed beneath the tank so as to allow for some warmer air to filter up from below and so reduce the risks of freezing.

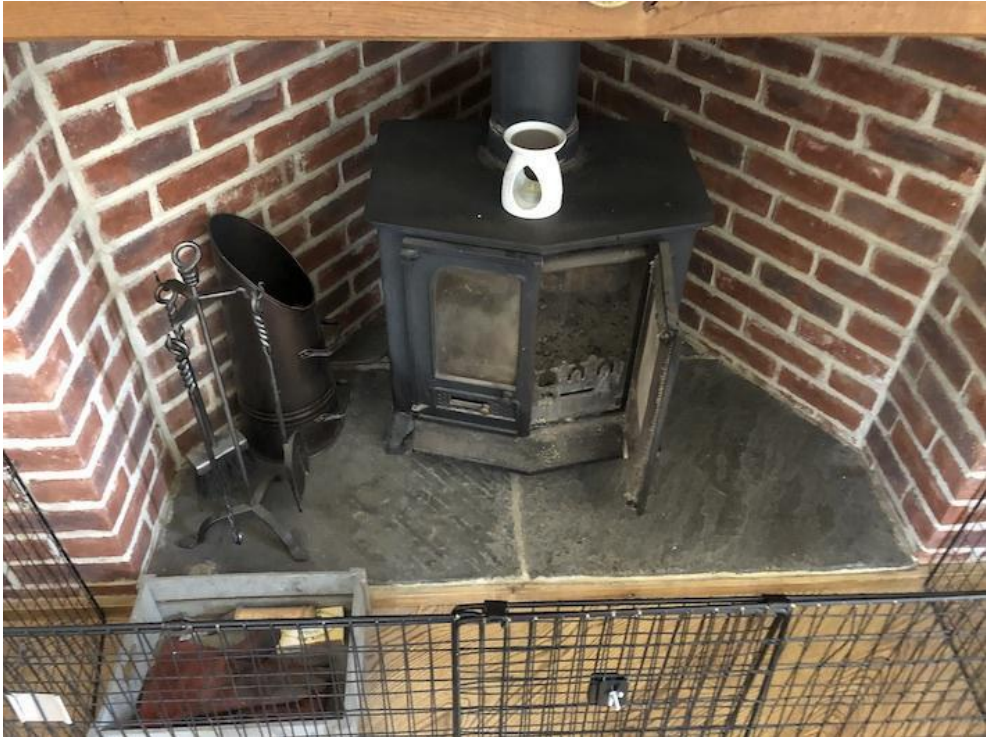
6.4 Heating and Cooling	Condition rating	3
Construction & Type	<p>The heating is provided by night storage heaters to all rooms except the kitchen and bathrooms.</p> <p>Additional heating is provided to the ensuite via an electric towel rail – this was not in operation at the time of the survey.</p> <p>The kitchen has a solid fuel range installed.</p> <p>There is a multi-fuel burner installed in the fireplace in the living room.</p>		
Nature of inspection and Limitations	<p>The heating in the property was turned off/no charged at the time of survey preventing checks of any associated services or fixtures being conducted.</p> <p>It is not possible to fully assess the condition and safety of an electric installation on the basis of a visual inspection only. A visual inspection was carried out of the radiators to detect corrosion and other common defects.</p> <p>Neither the kitchen range or reception room fire were checked for operation.</p>

Reception room fire

There is a solid fuel burning appliance in both the lounge and kitchen. You should ensure that carbon monoxide alarms are present.
