Home Condition Survey

Report Reference No: [REDACTED]
Produced for: [REDACTED]
Date: 31-Aug-2020
Surveyor: Mr David Clare

Type of property	The property is a detached house.
Tenure (legal advisor to check)	Freehold
Approximate year when property was built	2004
Approximate year the conservatory was built	2006
Weather conditions at the time of inspection	Dry, warm day, circa 20c with a clear sky.
The condition of the property when inspected	The property was occupied, fully furnished and habitable.
Is the property subject to special planning restrictions?	No.

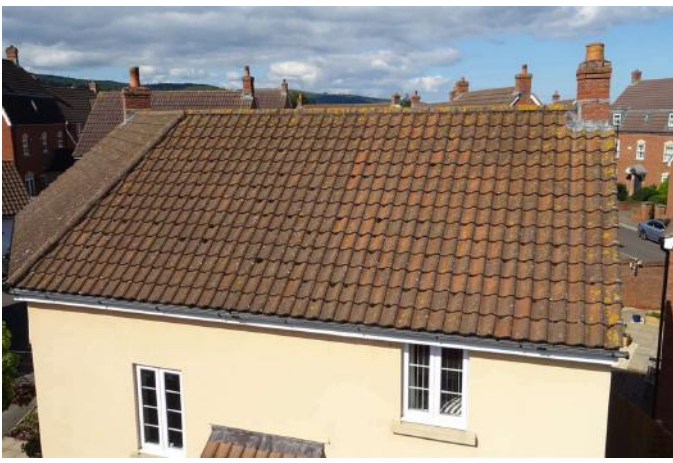
Front roof

<p>D2. Roof coverings</p>	<p>The main roof is shaped like a shallow 'V', it is dual pitched with a central lead valley at the rear and a corresponding single hip to the centre front.</p> <p>The roof is covered with interlocking concrete tiles. The tiles are laid over a modern breathable under felt, the intention of which used to cause any rainwater which passes between the tiles to be guided down to the gutters (see also section E1).</p> <p>The front storm porch canopy is a mono pitch roof covered in tiles to match the main roof.</p> <p>The lead flashings around the property look to be in good condition.</p> <p>Ridge tiles, and the single front central hip tiles, are made of concrete and bedded into mortar.</p> <p>Parts of the front central single hip ridge tiles mortar is degraded and has come away from the roof.</p> <p>The verge mortar (mortar on the gable walls at the end of the tile run) to both gables is cracked and not bonded fully to the undercloak (the board under the end tiles).</p> <p>The pitched roof coverings all around the property have some lichen and moss covering which should be removed as part of the maintenance program to prolong the life of the tiles.</p> <p>Some repair or replacement to the verge mortar (both gables) and hip ridge tiles mortar at the front of the property is required but this are not considered serious or urgent at this time, however if the mortar degrades further it will become urgent.</p>	<p>2</p>

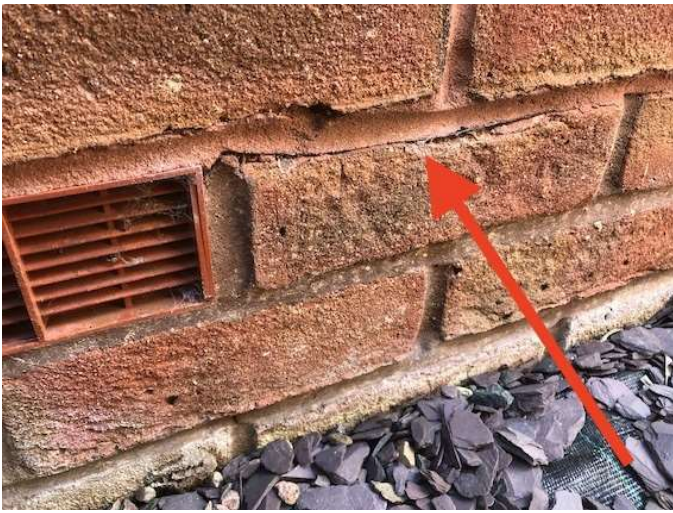
DPC

The damp proof course [water-proofing to prevent rising damp] is polyethylene and is found at 150mm or more above the ground level for most of the the perimeter of the house.

You should look to add extra sub floor air vents to promote cross flow of air to the sub floor void.

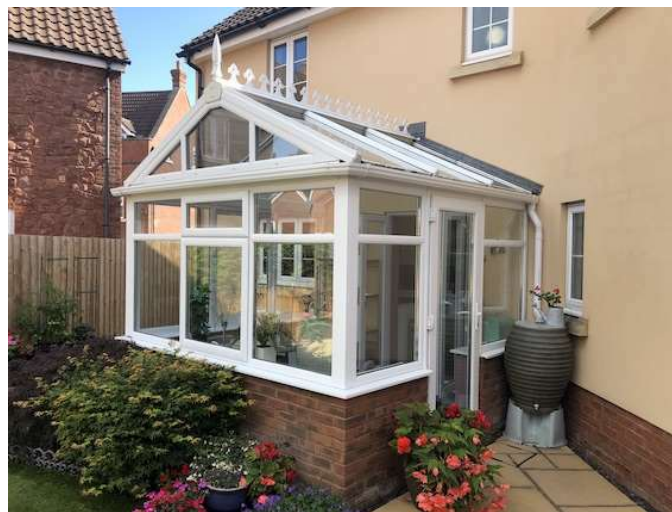
Conservatory

<p>D11. Conservatories</p>	<p>For the purposes of this report, a conservatory is a ground level structure attached to the property, but separated from it by external quality walls, doors and/or windows. And where at least three quarters of its roof and at least half of the external walls are glazed.</p> <p>The conservatory is of a PVCu double glazed construction and is on a brick plinth. The conservatory is in an average condition however it was inspected on a warm day which may have masked and disguised evidence of blown double glazed units.</p> <p>No repair is presently required. Normal maintenance must be undertaken.</p>	<p>1</p>

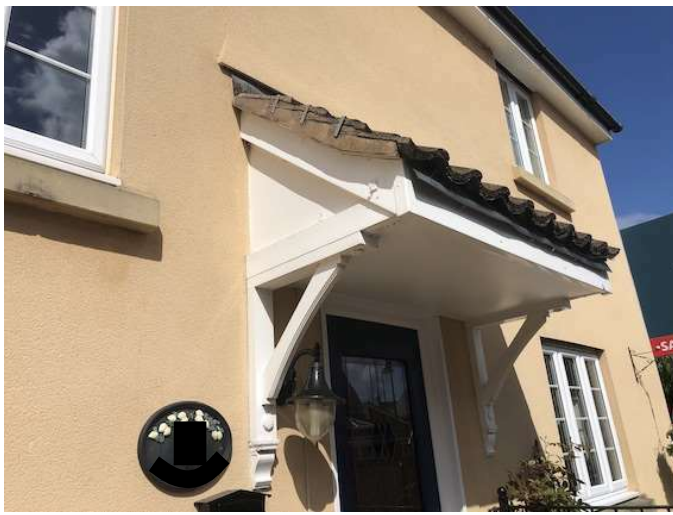
Storm porch

<p>D12. Porches</p>	<p>There is an open sided storm porch at the front of the property, a description of its roof is given in the main roof section of this report and the timber frame section of the porch is discussed in the outside decoration section of this report as it requires repair or redecoration.</p> <p>Some repairs or replacements are required but these are not considered serious or urgent.</p>	<p>2</p>
---------------------------------------	--	----------

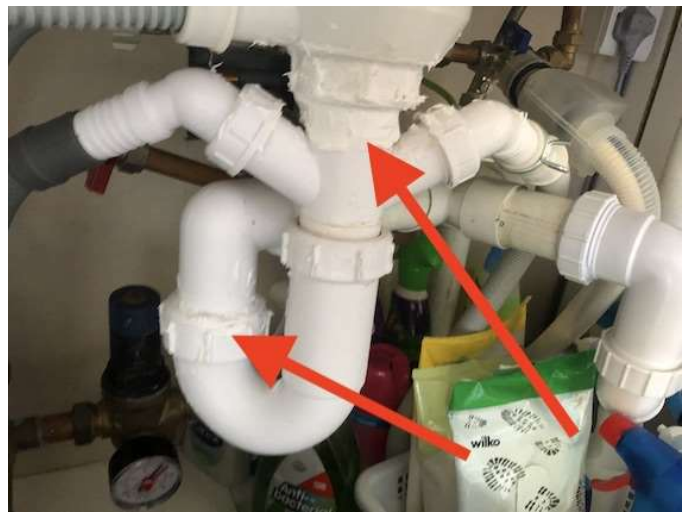
Sealant repairs

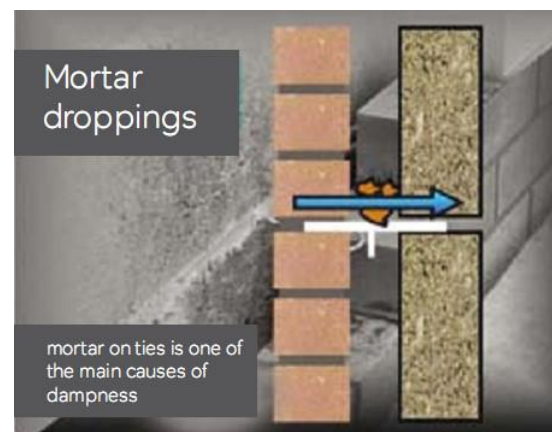
- Corrosion of the wall ties. Steel will corrode if not properly protected. Early wall ties were usually protected with a coat of bituminous paint. From about 1930 ties were covered with a coating of zinc ("galvanised") which gave them better protection, but this is considered substandard by today's standards. Any property built prior to 1981, when the standard of protection was improved, could be subject to premature corrosion of wall ties.
- Dampness caused by careless building practice. Wall ties have little tabs of metal ('drips') in the middle to enable any water which passes into the cavity to fall off them. If, due to poor building practice, mortar is allowed to collect on the tie when the wall is built, this will let water pass along the tie into the inner leaf, causing damp patches to appear on the inside of the wall (see Fig 3).

Fig3—Mortar dropping causing dampness

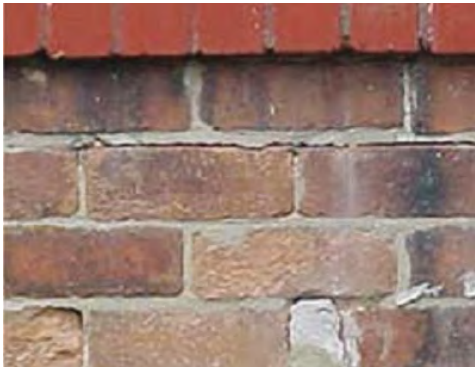
The main cause of deterioration of cavity walls is wall tie corrosion. If inadequately protected, the steel ties will rust due to the presence of air and water in the cavity. The constituents of mortar droppings can accelerate this process. When steel corrodes it will expand up to ten times the thickness of the parent metal. The ends of the wall ties embedded in the outer leaf will lift the bricks above, causing a horizontal crack to appear in the mortar joint (see Fig 4).

Fig4—Horizontal cracking in mortar joint

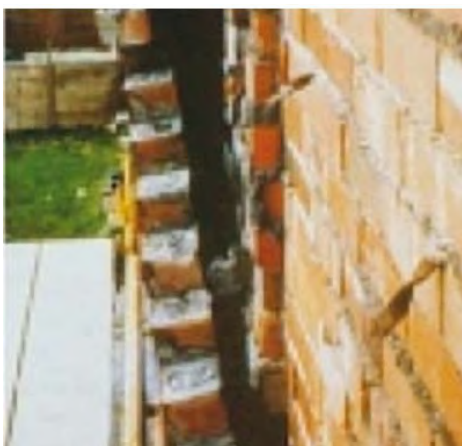
In extreme cases, the outer leaf can become separated from the inner leaf and fall off (see Fig 5). However, it must be stressed that this very rarely leads to any further collapse of the wall, and so there is no immediate threat to the safety of the occupants of the property.

Fig5—Separation of outer leaf

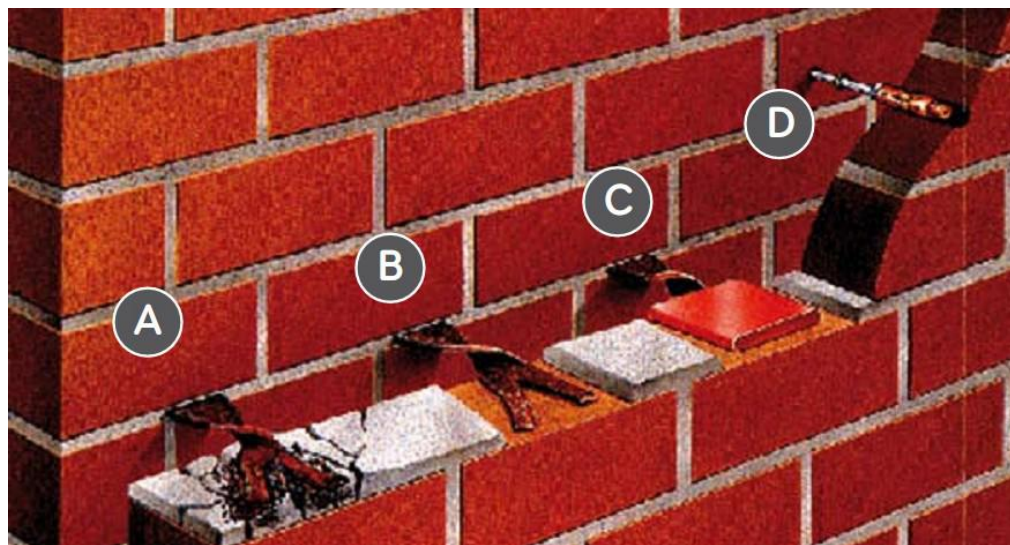
Fig6—Installation of replacement wall ties

- A**—rusted tie
- B**—tie cleaned for isolation
- C**—new expanding tie installed

This will normally consist of drilling holes through the outer leaf and into the inner leaf at specified centres and inserting stainless steel ties (see Fig 6).

After the replacement ties have been fixed the wall can be reinstated or made good and will then be in sound condition.
