BUILDING SURVEY REPORT

The format of this Mi BUILDING SURVEY REPORT is consistent with the guidance note requirements for a Survey Level 3 as defined by RICS Surveys of Residential Property 3rd edition May 2016

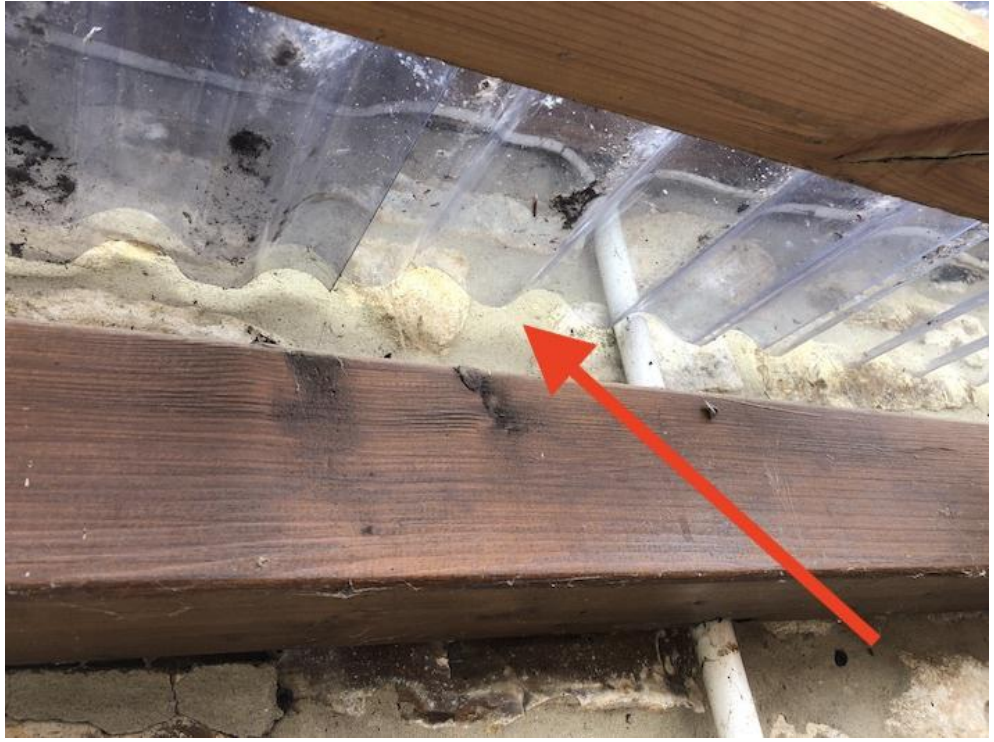
Boot room roof

Condition	<p>The gutters are currently in a serviceable condition and with no significant misalignment. No evidence was seen of excessive staining of the walls or adjacent areas, which might indicate that significant leaks have been occurring.</p> <p>There is no gutter servicing the boot room roof. See also section 4.7.</p> <p>The rear gutters have debris located in them.</p> <p>All gulleys were clear at the time of the survey with no evidence of any flooding or other drainage problems. However all gulleys require regular clearing of any debris that will accumulate over relatively short periods of time.</p> <p>The soil stack and associated plumbing is in a fair condition with no leakages noted.</p>		
Action Required	<p>The boot room requires a gutter to be installed to the downward roof edge to remove rain water from the roof and prevent damage to the fabric of the building.</p> <p>Gutters and downpipes should be cleaned and inspected regularly to ensure that they are free from blockages and leaks. If it is noted during any heavy rain, that gutters or downpipe joints are leaking, then these must be fixed as soon as possible to prevent water penetration to the property and damage to the foundations.</p> <p>Climbing plants and moss are prone to causing blockages in gutters and downpipes and should be removed from the area around the facilities on a regular basis.</p>

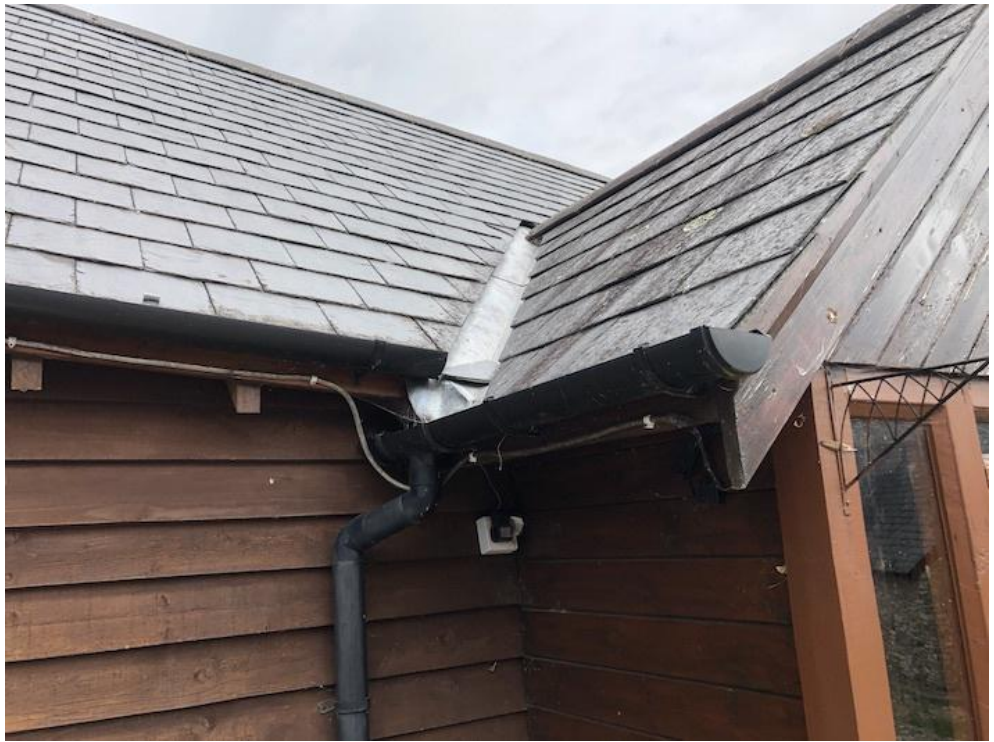
Front left valley

<p>Action Required</p>	<p>Pitched Sections:</p> <p>The sag to the ridge looks to be located mostly if not fully on the right side adjoining neighbours property, however the sagging section closely runs next to or over the party line, this is seemingly caused by roof spread on the adjoining property roof structure but may still be ongoing and will require monitoring going forwards to ensure it is not active movement.</p> <p>The roofing underfelt at the eaves to guttering should be replaced to prevent future moisture ingress, this generally requires a partial strip off of slates in order to fit new felt before the roof covering is refitted. You should note that scaffolding may be required in order to undertake this type of work.</p> <p>Any slipped, missing or broken tiles on the roof pitches should be repaired and replaced. You should carry out a thorough visual inspection at least once a year, ideally in the Spring to identify and repair any damage that could have been caused by winter weather. Any missing mortar at the verges and beneath any hip or ridge tiles should be replaced. Any moss or other accumulated plant matter should be cleared</p> <p>The boot room roof should be extended, or replaced fully, to meet the rear elevation wall and to prevent water ingress to the room.</p> <p>Ongoing, carry out normal maintenance including the removal of moss build-up.</p>

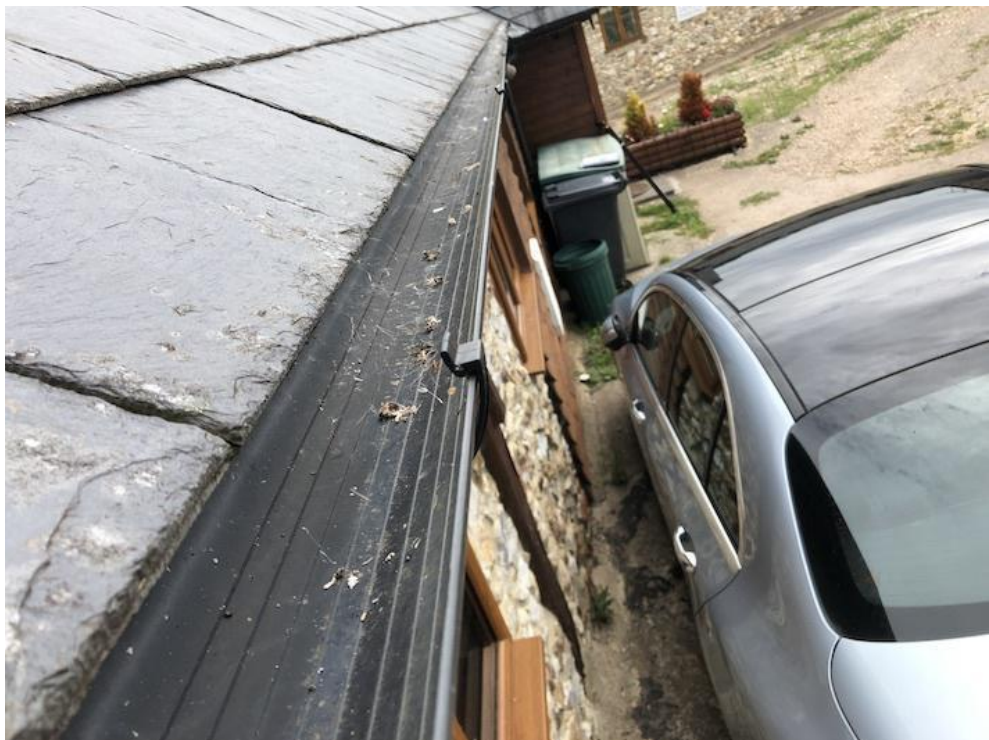
Front gutter clear

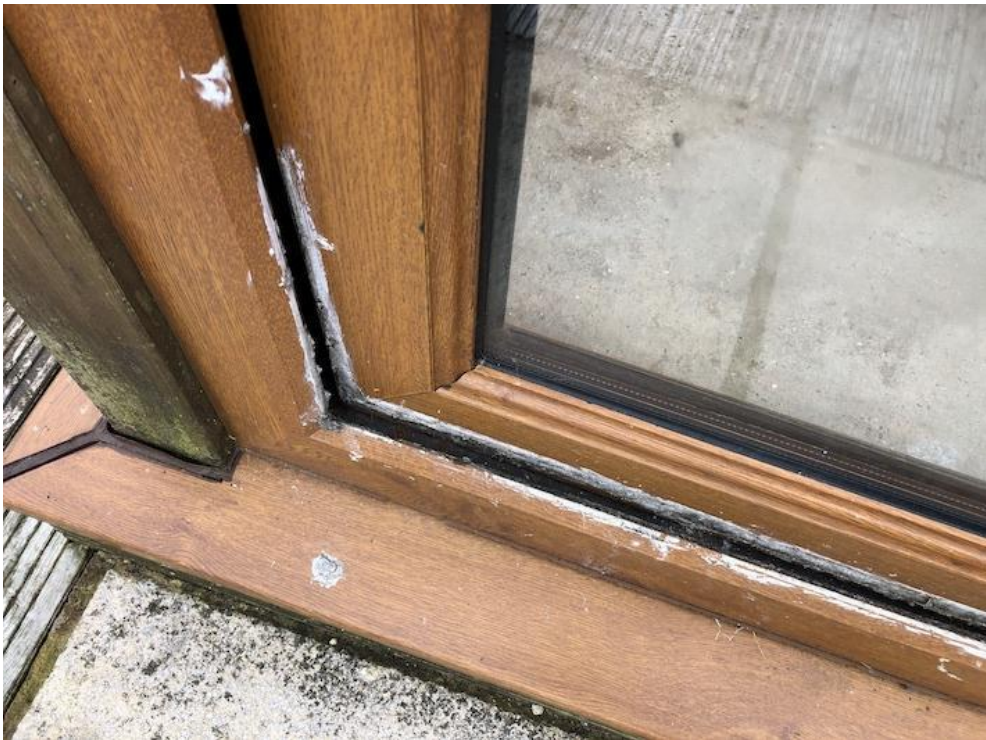
Boot room door

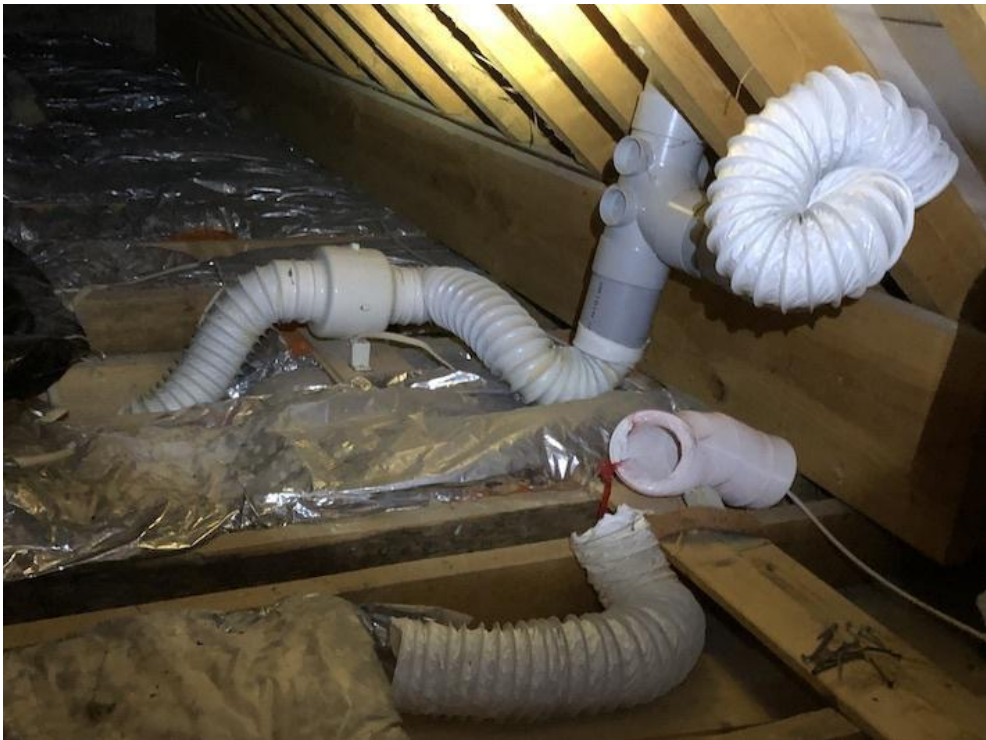
<p>Condition</p>	<p>The roof structure is in a good condition with no evidence of structural failure or unusual movement. The rafters, purlins and strut timbers are complete with no evidence of any undue stress or cracking. The underfelt (secondary waterproof covering) is complete with no major tears or missing sections.</p> <p>No evidence was seen of infestations by wood boring insects (commonly known as "woodworm"), however rodent droppings were found in several locations and specifically towards and above the bathroom areas. See section 3.2.</p> <p>High moisture levels within roof spaces are responsible for the promotion of the development of timber defects such as rot and infestations by wood boring insects (commonly known as woodworm). Wood moisture content readings taken were found to be well within normal limits and below the levels normally required for this type of defect.</p> <p>The mechanical extractor vent ducting is should be present for both the bathroom and ensuite extractors, however only one pipe is located in the loft and only one is connected to the exterior vent pipe. This means moist air from the ensuite is not venting to the outside but is instead venting into the loft. This risks introducing moisture and rot into the loft.</p> <p>The roof space is laid with 100-150mm of foil quilt type insulation at joist level. Increasing the thickness to the current recommendation of 270mm is recommended for increased energy efficiency, but when adding insulation it is important to maintain good ventilation within the roof space and not to block ventilation grillws or openings.</p> <p>As indicated in section 4.6, the soffit boards [panels that link the gutter boards to the walls] have ventilation grilles to supply cross ventilation to the roof space. These should be kept clear, with insulation pulled back to free the space at the eaves. Without adequate ventilation condensation can form on the underside of the roof surface and hence introduce dampness to the roof space.</p>

MEV Pipes

<p>Action Required</p>	<p>The ensuite extractor fan ducting needs to be repaired or replaced, make sure that hoses passing through the roof space extend to an external grille so that warm moist air is not ventilated into the roof.</p> <p>Instruct an exterminator to set traps, remove and/or exterminate the rodent population that is getting into the roof space. At the same time take advice from them as to how the animals are getting into the loft and prevent this from re-occurring.</p> <p>It is important to ensure that spaces remain well ventilated so as to reduce the likelihood of the development of defects such as rot and infestations by wood boring insects. In many cases, ventilation derives from openings at the eaves at the edge of the roof, though these can become blocked where insulation is forced into the spaces. When adding or replacing insulation, make sure that good ventilation is maintained.</p> <p>Care should be taken when moving around, or storing heavy objects, in the roof space. The spaces between the floor joists will not support a persons weight, or that of large boxes etc. Where heavy items are to be stored it is important to distribute the weight evenly using fixed boards. Additional structural support may be required if you plan to store large quantities of heavy items in the roof space.</p>

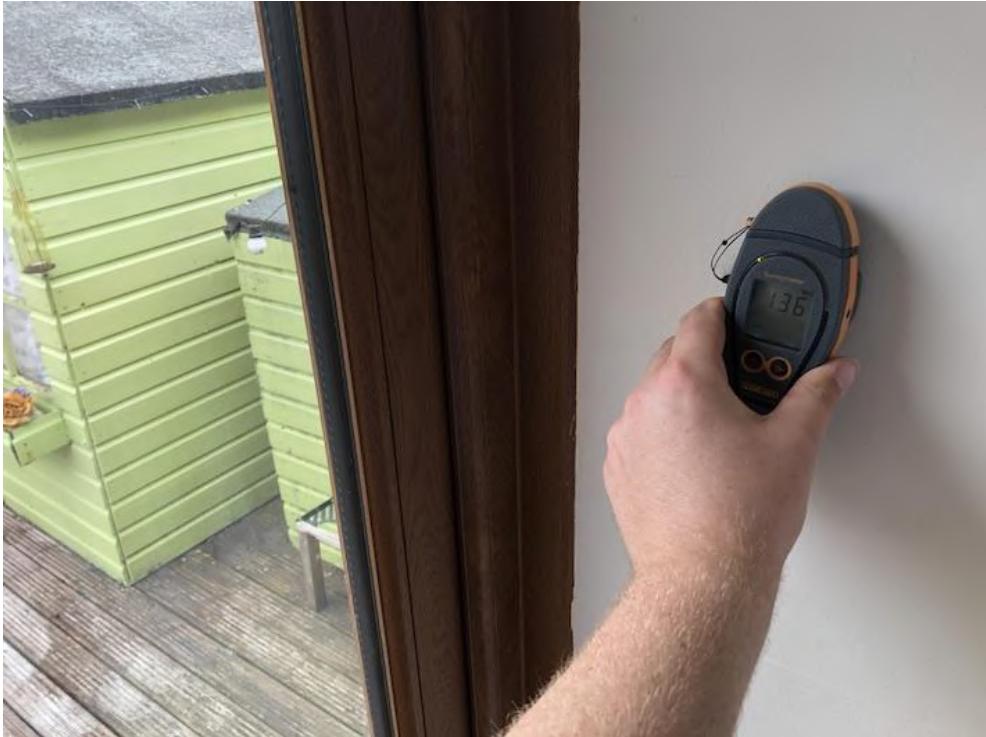
Example low damp reading

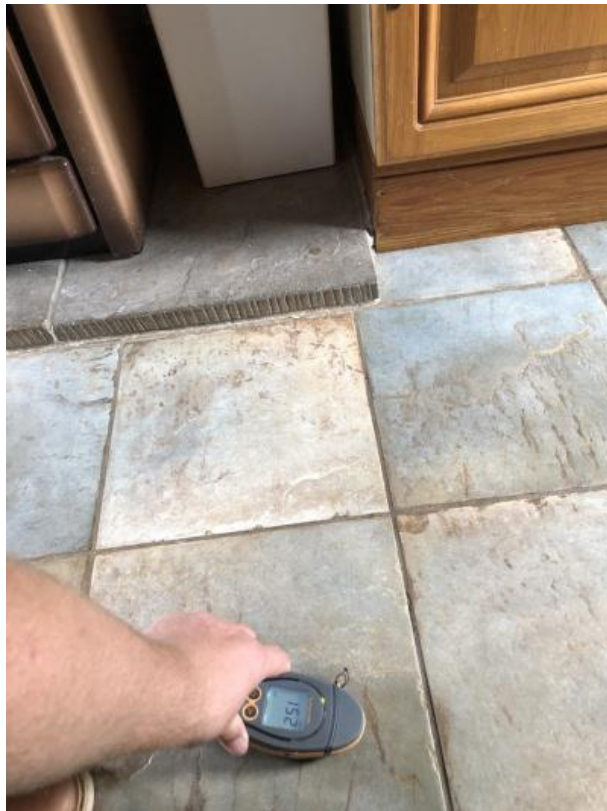
Example low damp reading

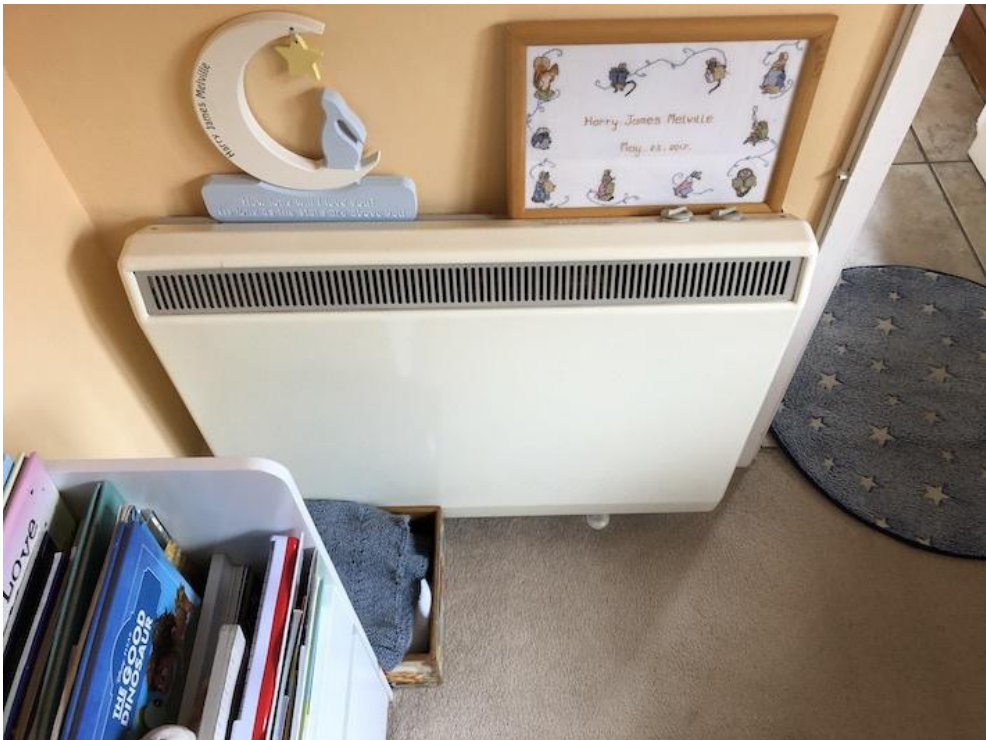
Condition	<p>Electric storage heaters use less expensive electricity that is only available during the night to heat a core of 'fire-bricks'. The heater releases the stored heat into the swelling during the day. This is an older system that is difficult to control and can cool down quickly. In cold weather you may need to use other forms of heating and this can be expensive.</p> <p>The energy efficiency rating in the energy performance certificate is likely to be lower than other properties with different heating systems. This may affect the saleability of the property.</p> <p>No sweep certificates were supplied to show recent sweeping of either the reception fire flue or the kitchen range flue.</p> <p>I have not carried out a smoke test of the reception room fire or the kitchen range as this is beyond the scope of this inspection.</p>		
Action Required	<p>No visible repairs were noted; normal maintenance servicing must be continually undertaken.</p> <p>Health and Safety – See also notes in 6.1 regarding the general safety and servicing of the complete Electrical system.</p> <p>Before any fire is lit to the reception room fire or the kitchen range you should seek the advice of a HETAS approved chimney sweep (for more information see the HETAS website at www.hetas.co.uk/find-chimney-sweep/).</p> <p>Advice: The water temperature in a hot water storage tank should be around 60°C in order to kill legionella bacteria (which can cause Legionnaires Disease), and no more than 50-55°C at taps in the property.</p>

Electric heater

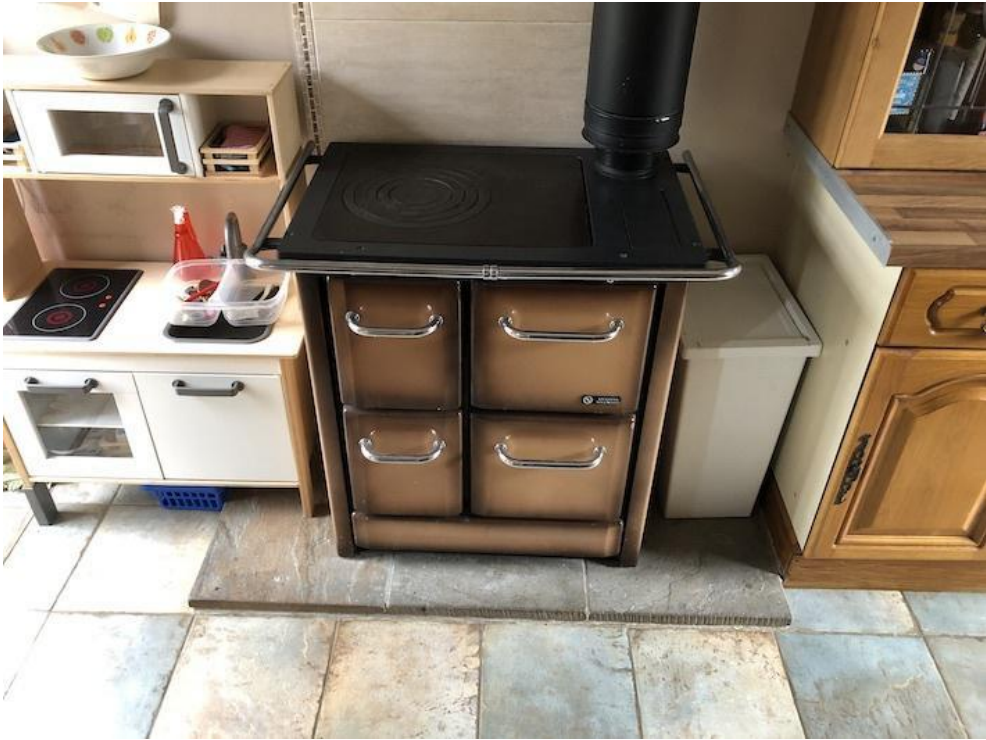
6.4 Heating and Cooling	Condition rating	3
Construction & Type	<p>The heating is provided by night storage heaters to all rooms except the kitchen and bathrooms.</p> <p>Additional heating is provided to the ensuite via an electric towel rail – this was not in operation at the time of the survey.</p> <p>The kitchen has a solid fuel range installed.</p> <p>There is a multi-fuel burner installed in the fireplace in the living room.</p>		
Nature of inspection and Limitations	<p>The heating in the property was turned off/no charged at the time of survey preventing checks of any associated services or fixtures being conducted.</p> <p>It is not possible to fully assess the condition and safety of an electric installation on the basis of a visual inspection only. A visual inspection was carried out of the radiators to detect corrosion and other common defects.</p> <p>Neither the kitchen range or reception room fire were checked for operation.</p>

Range

There is a solid fuel burning appliance in both the lounge and kitchen. You should ensure that carbon monoxide alarms are present.

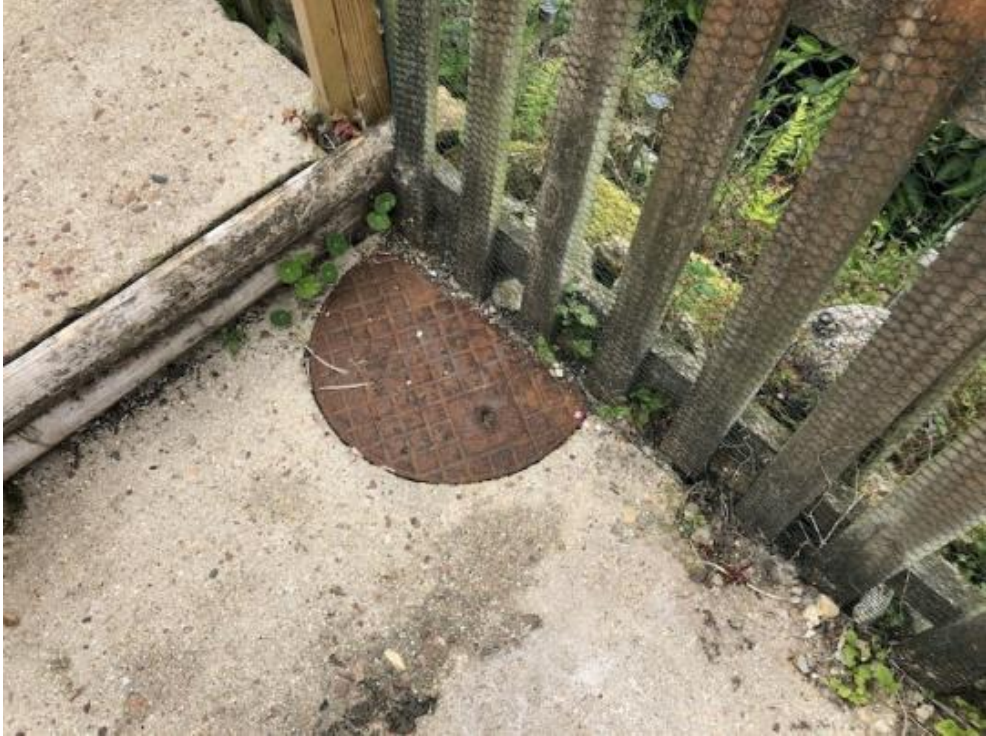
<p>Inspection chamber</p>

6.5 Drainage	Condition rating	NI
<p>Construction & Type</p>	<p>The property is understood to be connected to a shared private septic tank drainage system. Your conveyancer should confirm this to be the case and advise the person to whom fees are payable in respect of sewerage.</p> <p>There is one inspection chamber located to the rear of the property. The chamber has a cast-iron cover but this is partially covered over with facing and can not be lifted. It should be noted that the underground drainage network was not inspected visually or with the use of cameras and therefore no assessment could be made.</p> <p>However, internally, all taps were run and WC's flushed, and water was seen to be running clear from the internal services.</p> <p>Further advice should be obtained in the form of a septic tank survey prior to exchange of contracts as under the Environmental Permitting (England and Wales) Regulations 2016 if you have an existing septic tank that discharges in to a watercourse, river or stream you will have to either upgrade to a sewage treatment plant or install a drainage field system, this is expensive if remedial work is needed.</p> <p>As inspection chambers could not be accessed during the survey you should ask an appropriately qualified person to inspect/conduct a CCTV survey to ensure the drainage runs are in good order, it is advisable to do this before exchange of contracts.</p>

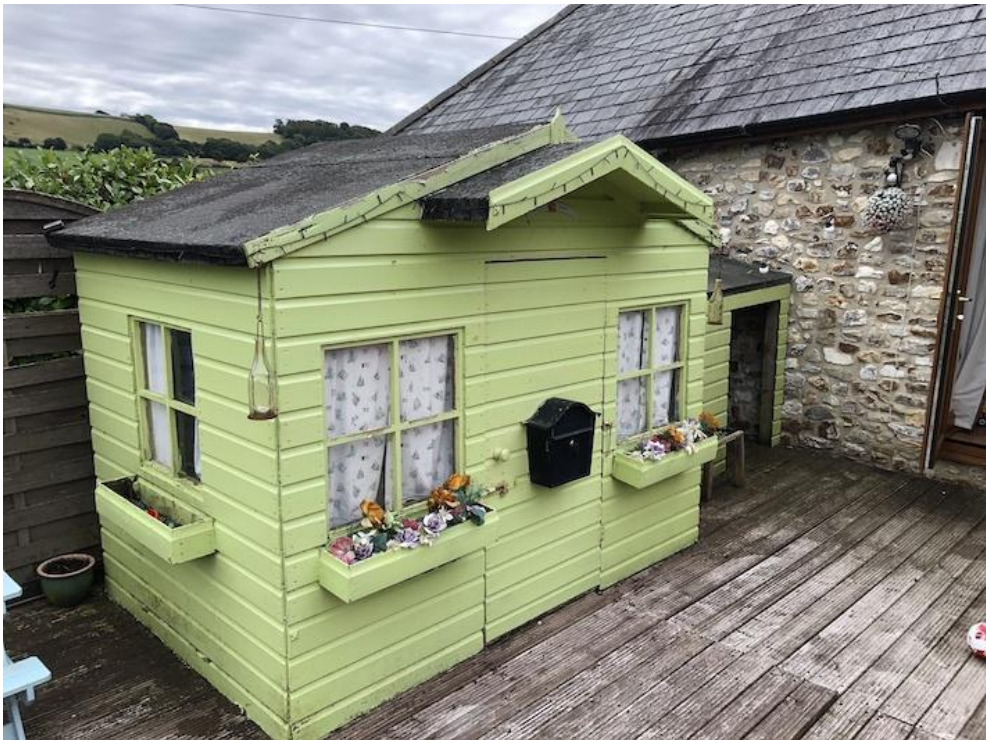
Condition	<p>The shed was found to be in a stable condition with no evidence of rot but is in need of redecorating as this has failed.</p> <p>The summerhouse was found to be in a stable condition with no evidence of rot but is in need of redecorating as this has failed. The felt roof is failing and starting to delaminate.</p> <p>The open sided shed is suffering decay and sporadic areas of timber rot, the decoration to the frame and boarding has failed. The underside of the roof shows a large water stain where rain water is penetrating the felt roof and damaging the deck (roof underside) as a result of this.</p>		
Action Required	<p>Normal maintenance, including regular re-treatment of the timber, is required to all three structures. Areas of rot need to be treated and/or replaced in the short term. The open sided shed is particularly run down and you may consider replacing this upon taking occupation.</p> <p>The felt roofs to the summerhouse and open sided shed need repair or replacement. Compared to traditional coverings such as tiles and slates, most felt roofs have a typical life of 10-25 years. They are also prone to sudden failure and leakage. Periodic re-covering will therefore be necessary. When this is undertaken, the supporting structure may also need some attention.</p>

Summerhouse

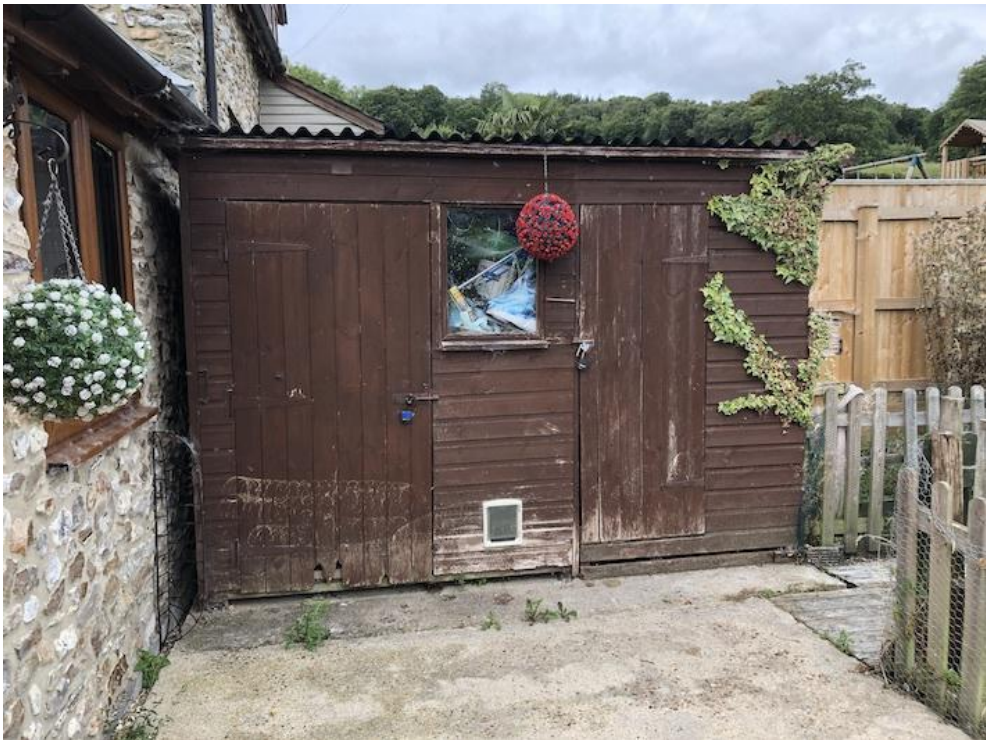
Main shed

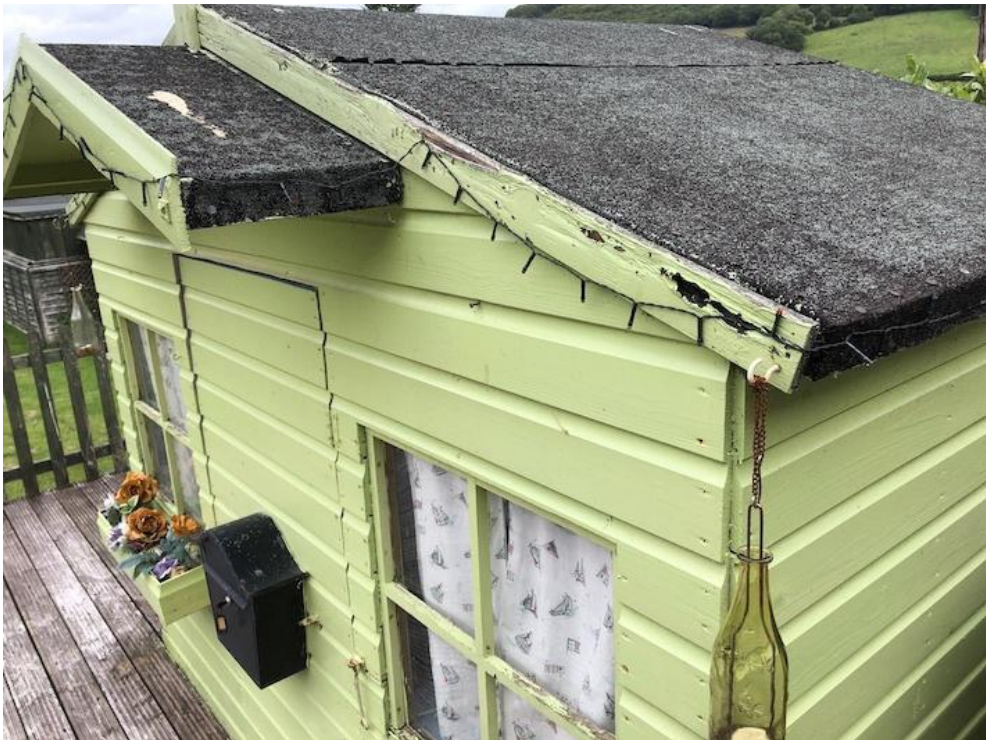
Summerhouse roof

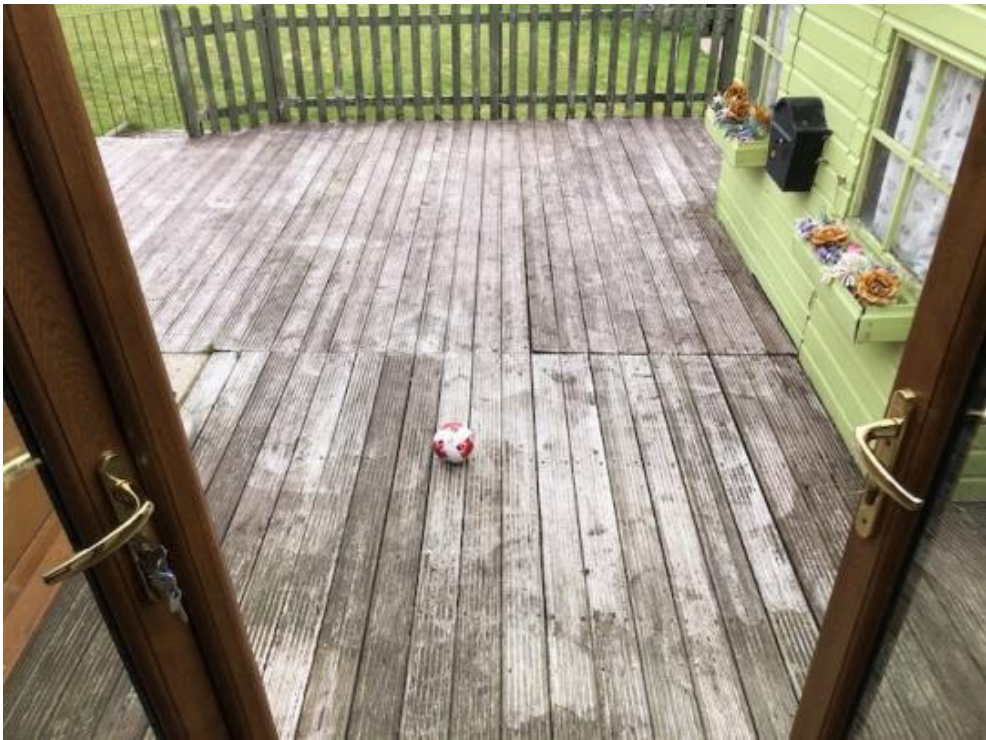
<p>Condition</p>	<p>The rear garden is presented in a poorly maintained condition.</p> <p>The concrete hard standing area is split outside the bathroom area, this has been previously patch repaired but is failing once again.</p> <p>The decking is rotten and collapsed in sporadic areas, specifically in a large section to the rear of the main shed.</p> <p>The fencing and gates surrounding the decking move and have paint failure. There is a gap in the fencing where a slide has been attached.</p> <p>The boundary left fence has damage to one panel, a section of wood has split and detached.</p> <p>The brook running though the centre of the rear garden parallel to the rear of the house poses a risk of flooding if it is blocked or if heavy rain were to suddenly fall. A concern here is the low level of the rear damp proof course, as noted in section 4.4. However, there is no evidence of any damage from recent flooding.</p> <p>No evidence of the presence of Japanese Knotweed was seen during my inspection but you are advised to seek further advice if you believe it may be present or are aware that it is present in premises nearby.</p> <p>There is no indication of the ownership of any of the boundary walls, fences or hedges, and in most cases this is not specified by the deeds or title documents. Often, responsibility for boundaries to one side or another has been assumed by subsequent owners. You should ask your conveyancer to advise on any indications of ownership included in the title documents.</p> <p>Repairs are needed to the rear boundary fence as it is listing.</p> <p>No obvious evidence of subsidence or other unusual ground movement was seen.</p>

Decking

<p>Action Required</p>	<p>The items identified in the condition box above all need repair or replacement.</p> <p>The replacement or part replacement of the deck, considering it is raised more than 30cm off ground level, may require planning permission.</p> <p>Once the grounds are brought back to a fair condition then regular maintenance is required going forwards.</p> <p>As previously noted the apparent allocated parking spaces are not listed on the land registry title plan and as such your conveyancer needs to confirm title, rights of way, easement, location and any ongoing maintenance fees associated with the parking spaces. It should be further noted the parking spaces are in a similar condition to the private main access road (see section 7.4), basically requiring full resurfacing and levelling.</p>

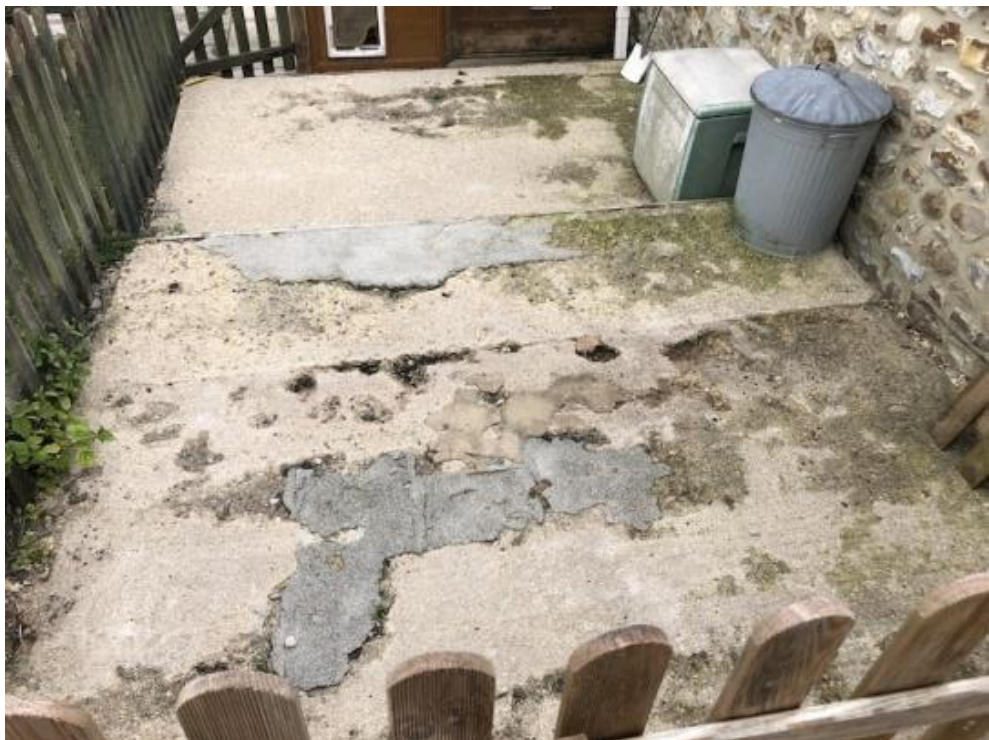
Rear garden hard standing

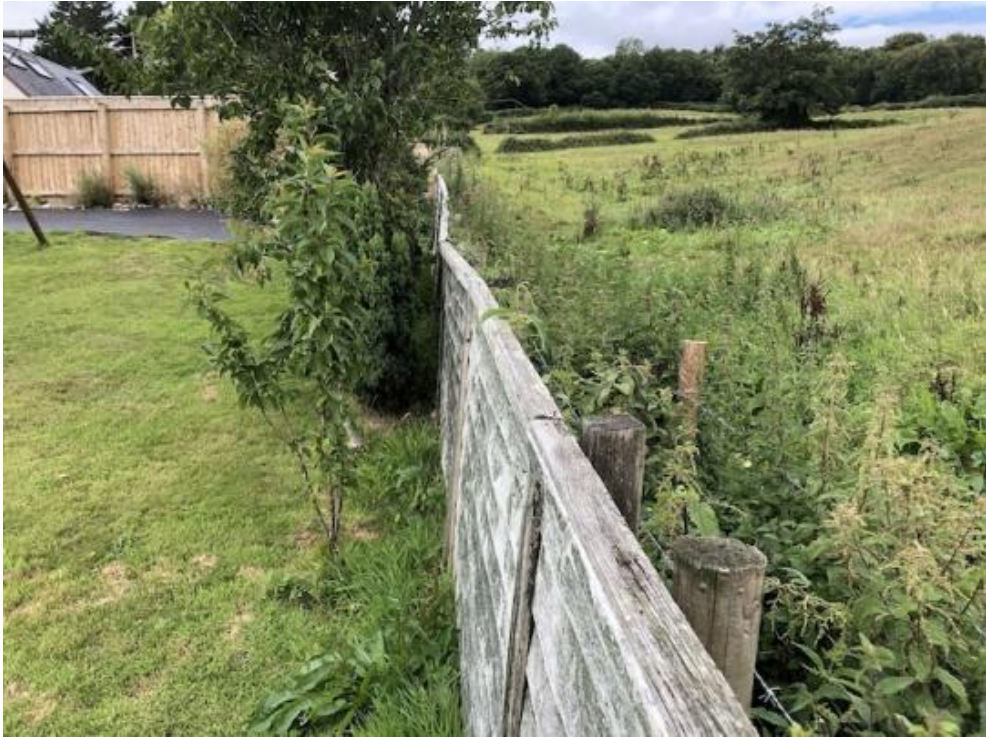
Rear fence

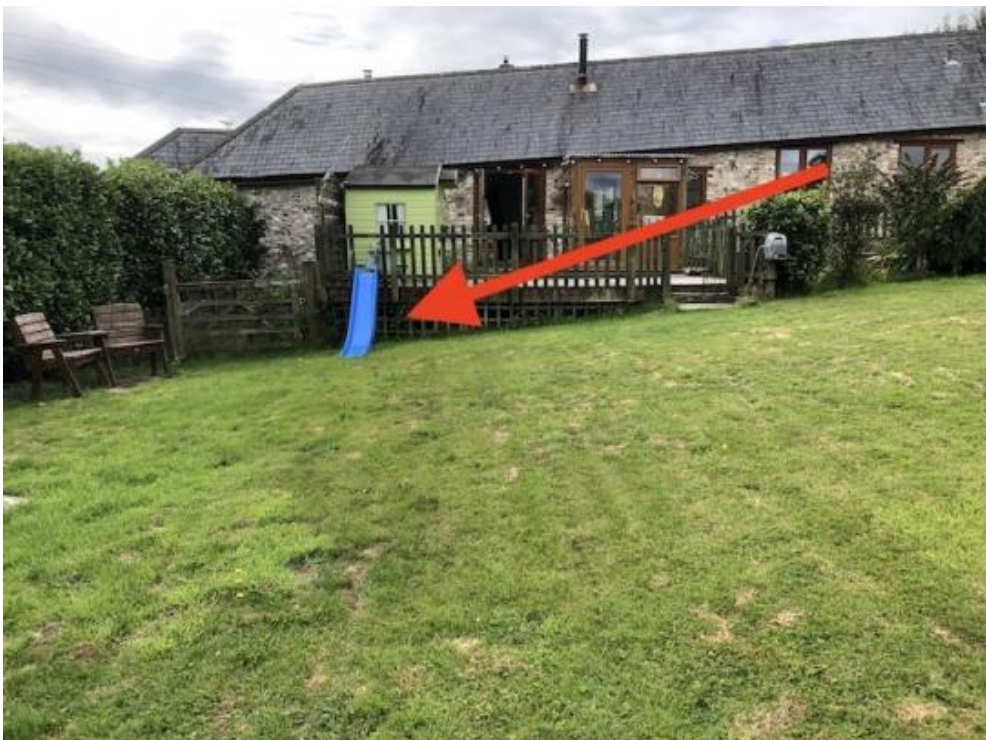
Deck height
